ethOss<sup>®</sup>

Volume 1

CASE  
STUDY

## Table of contents

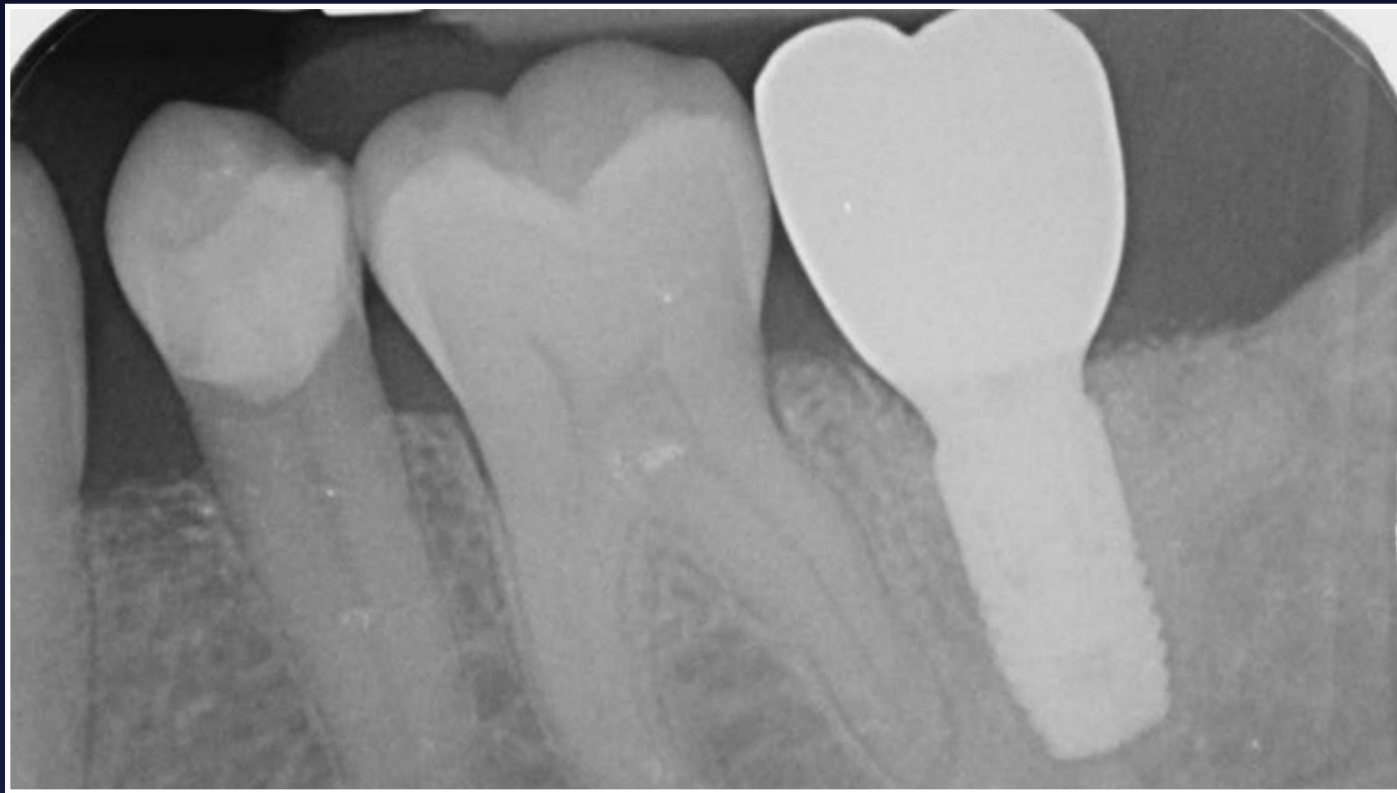
1. Final PA showing excellent results

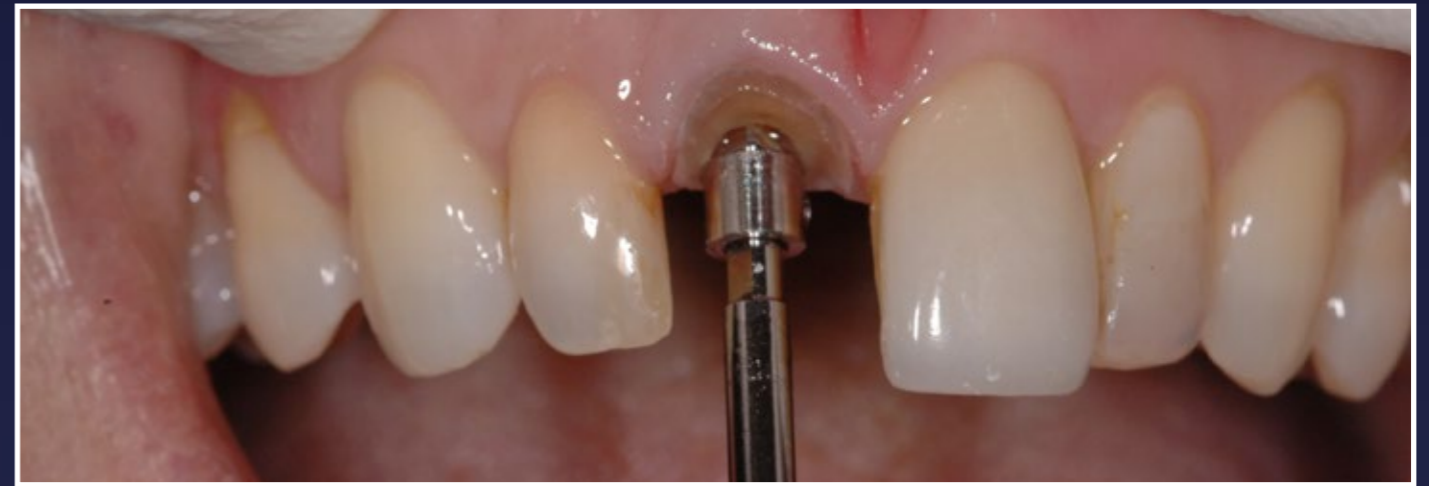
6. Partial extraction therapy preparation

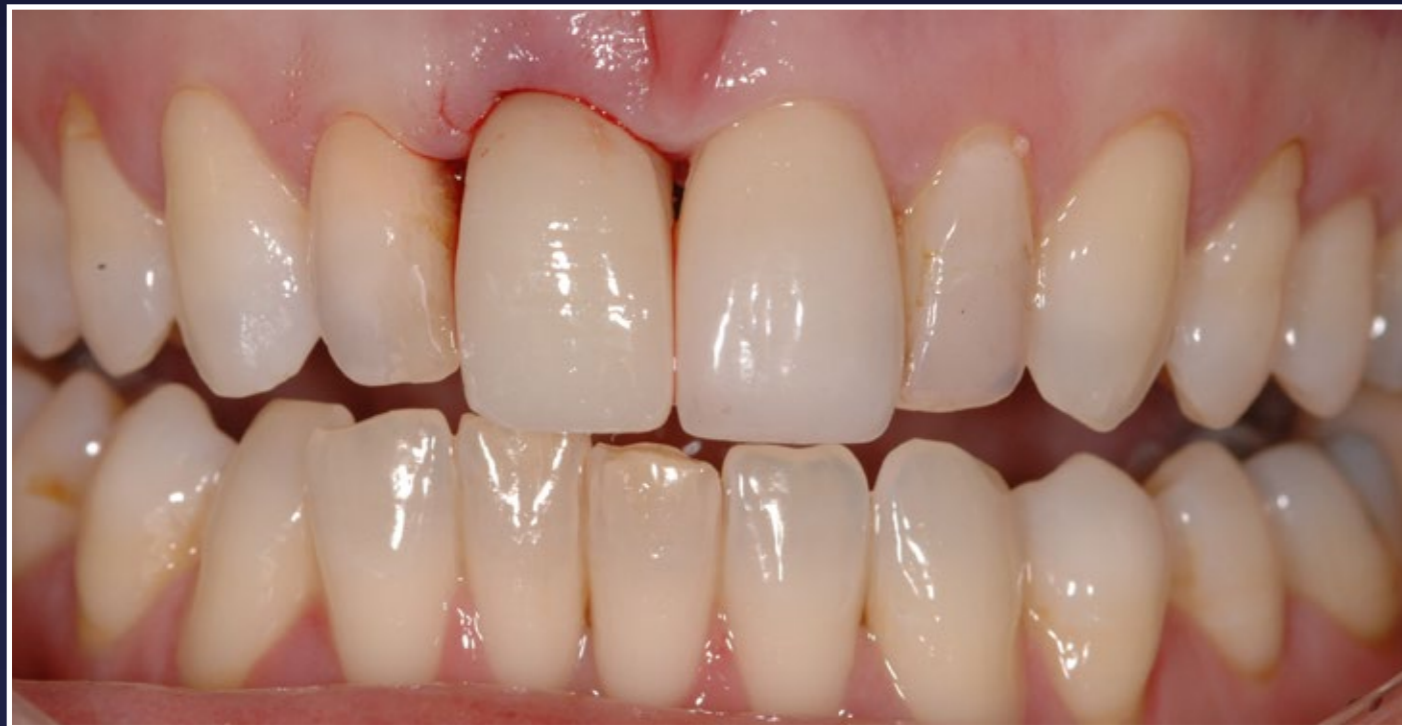
17. Immediate restoration

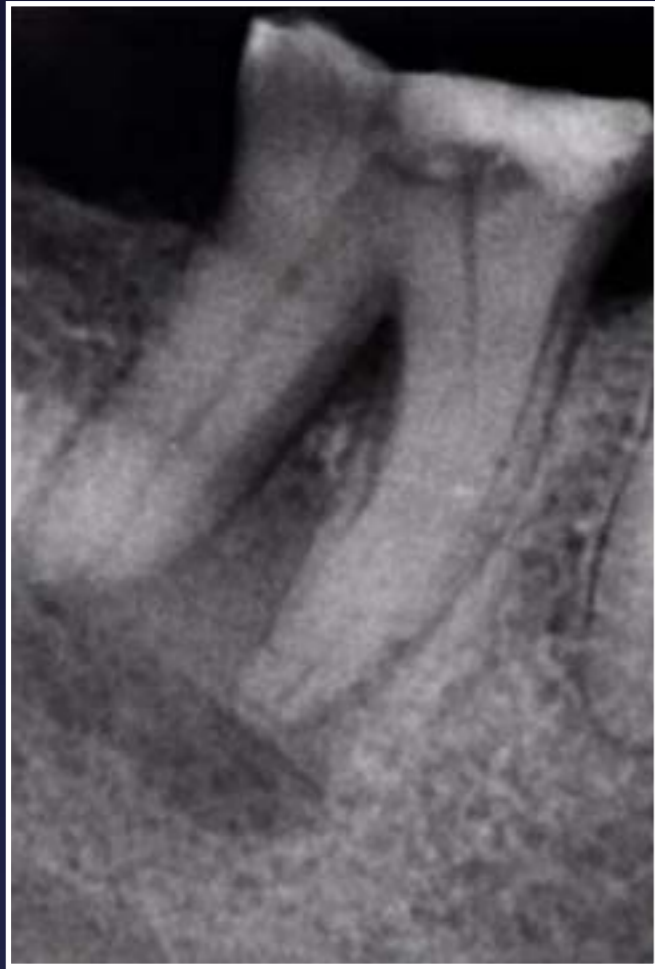
1. Referred to Endodontist but was advised of poor prognosis due to fracture in MB root

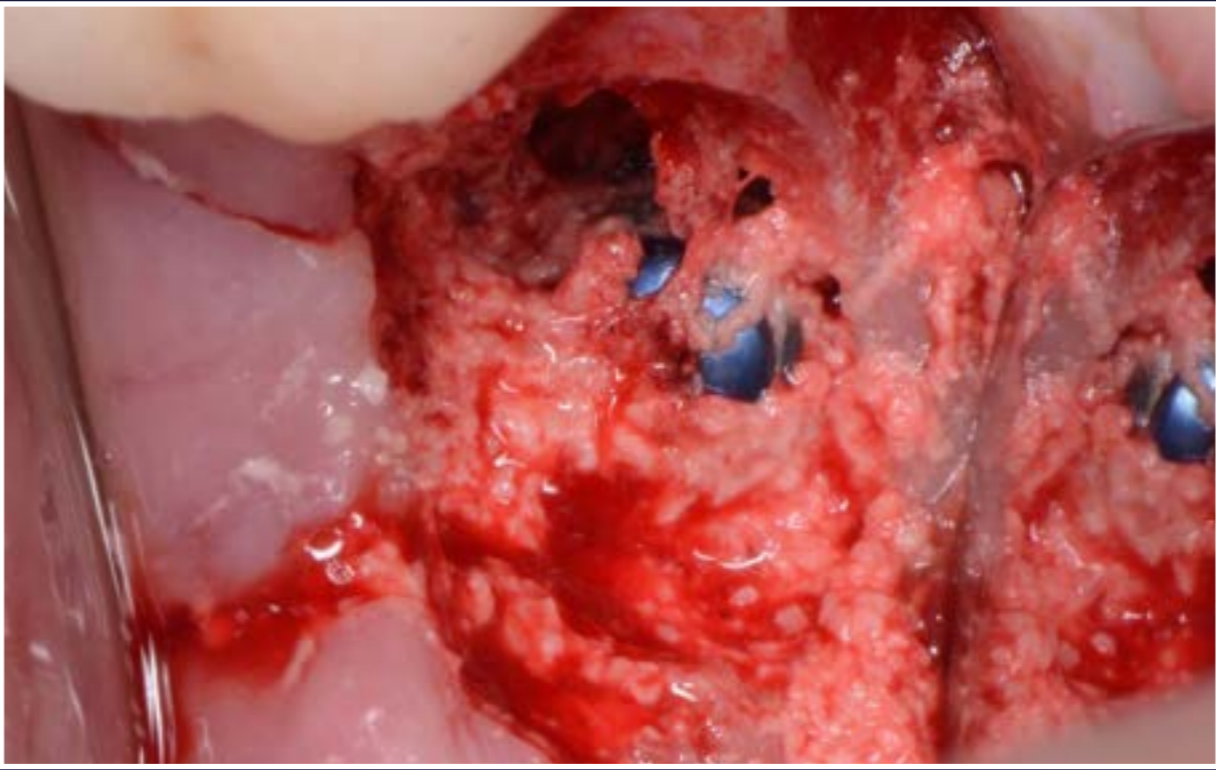
4. Due to nature of site decided to place EthOss and then push a 5mm by 8.5mm AnyRidge implant directly into the graft with no primary stability or bone to implant contact. Graft material was allowed to set whilst implant was held in place with cover screw driver

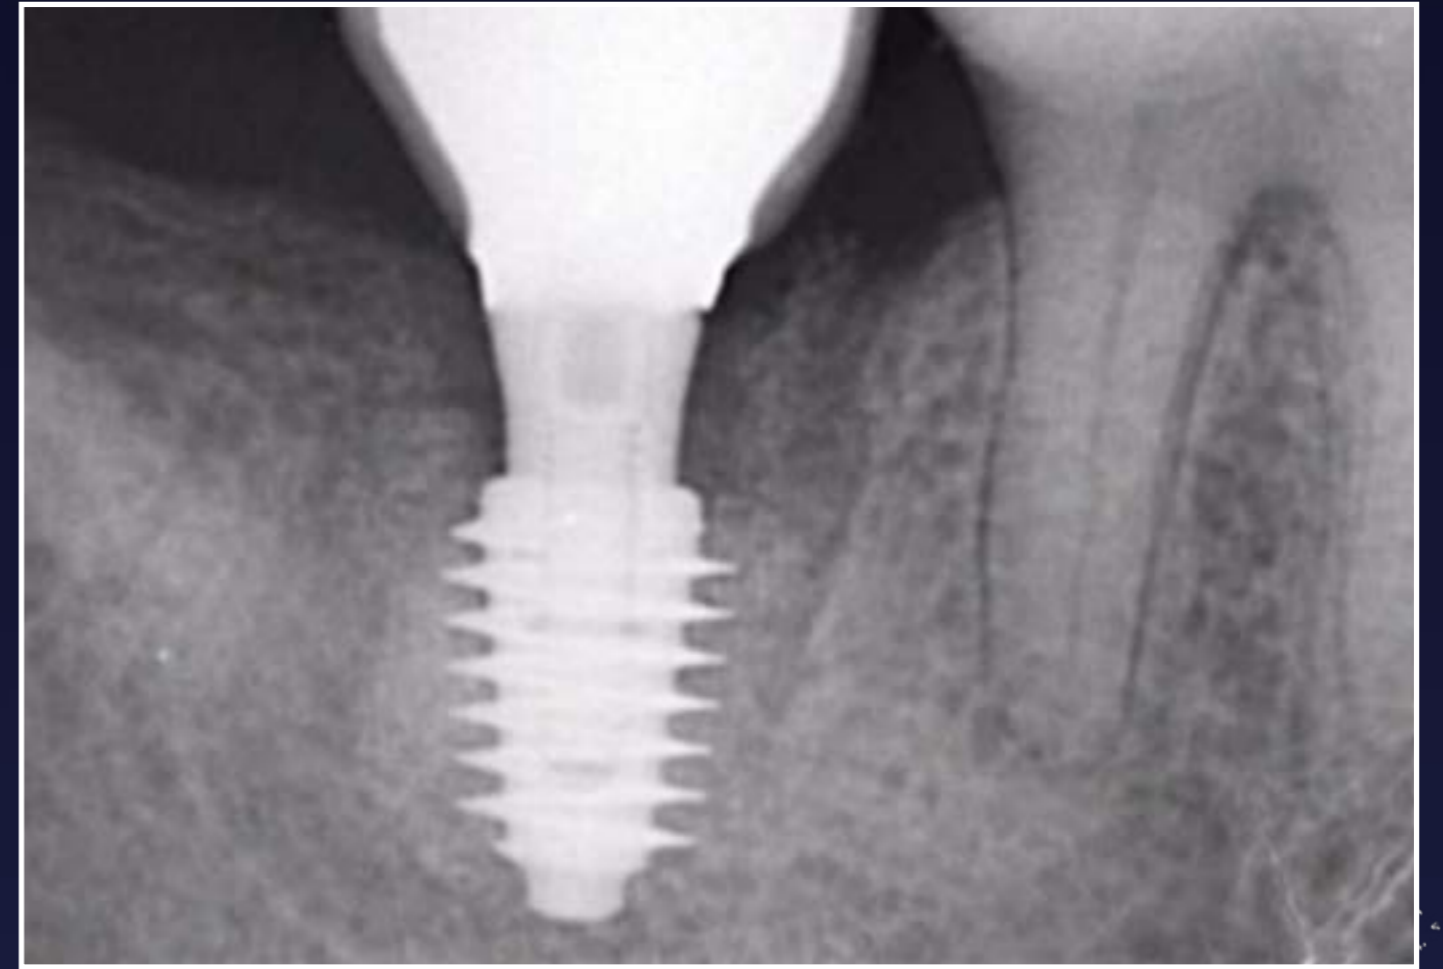
18. Case loaded - stability reading of 76 ISQ

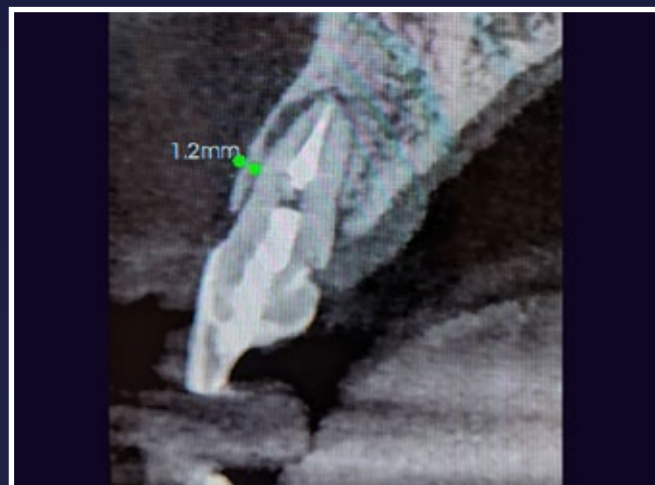
2. Pre-op radiograph shows preserved root and bone intact although a bit of bone loss on the palatal side

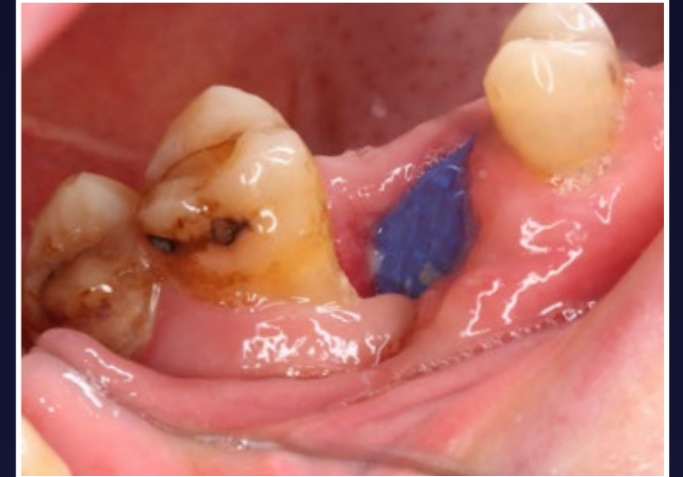
6. 2 weeks later difficulties caused by lack of stability of both materials. After two additional weeks the membrane came off by itself

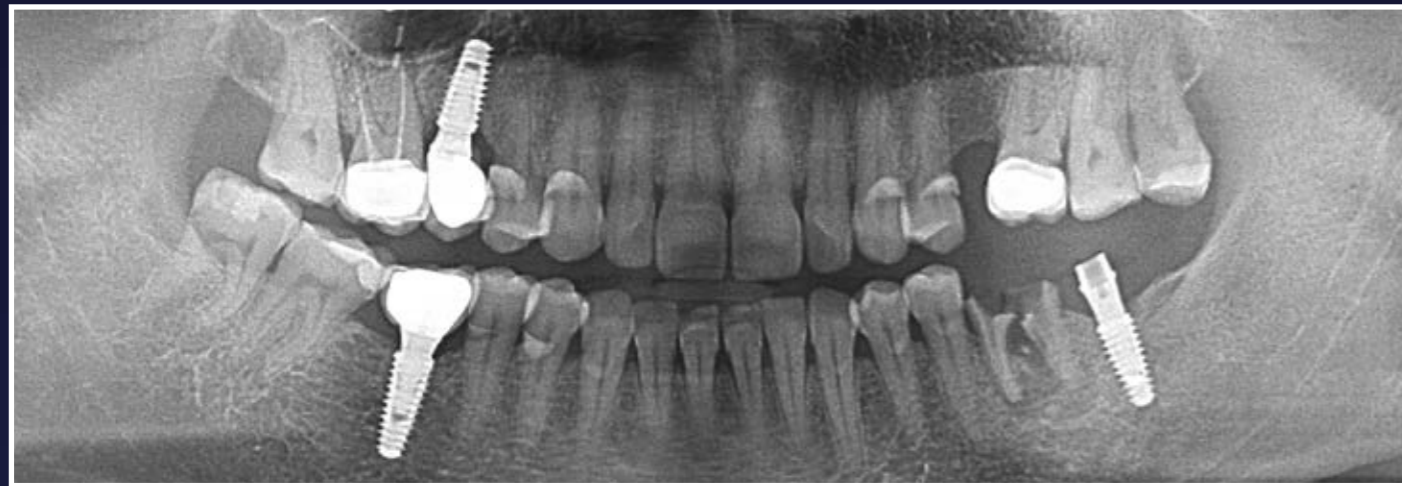
1. Panoramic radiographic - initial LL6 (36) is lost

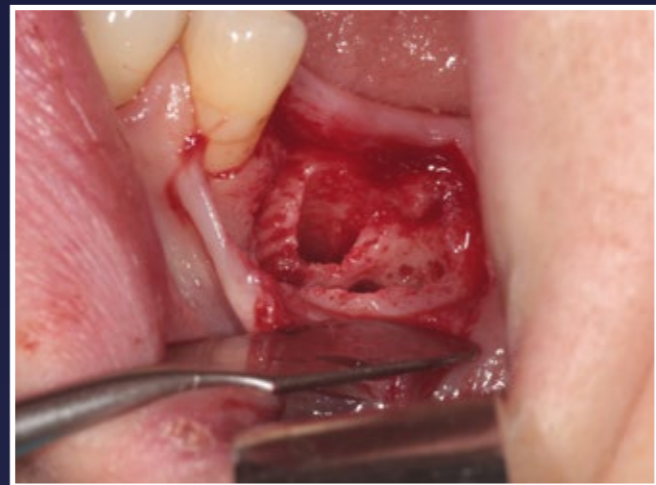
3. Large defect in bone, bad healing

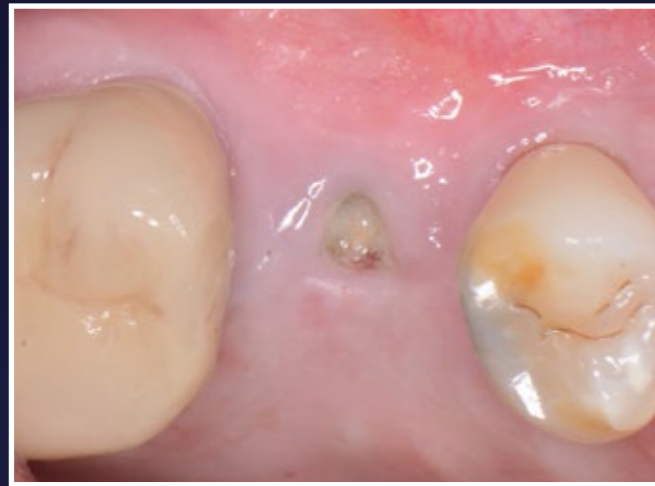
1. Fractured screw, implant could not be removed

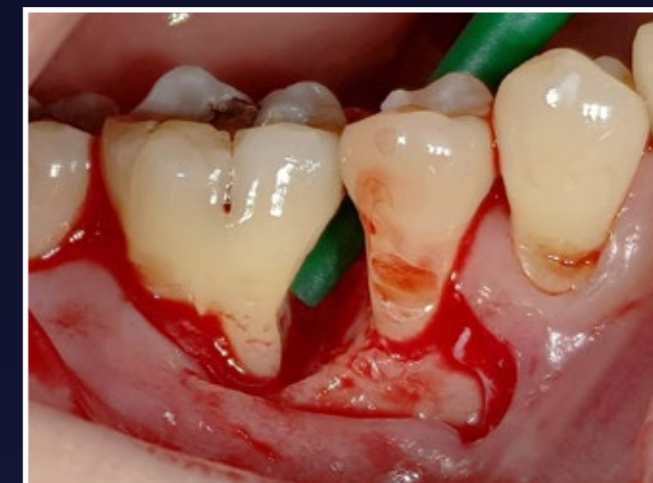
5. Following cleaning defect is visible - apically 2 walled, coronally 1 walled

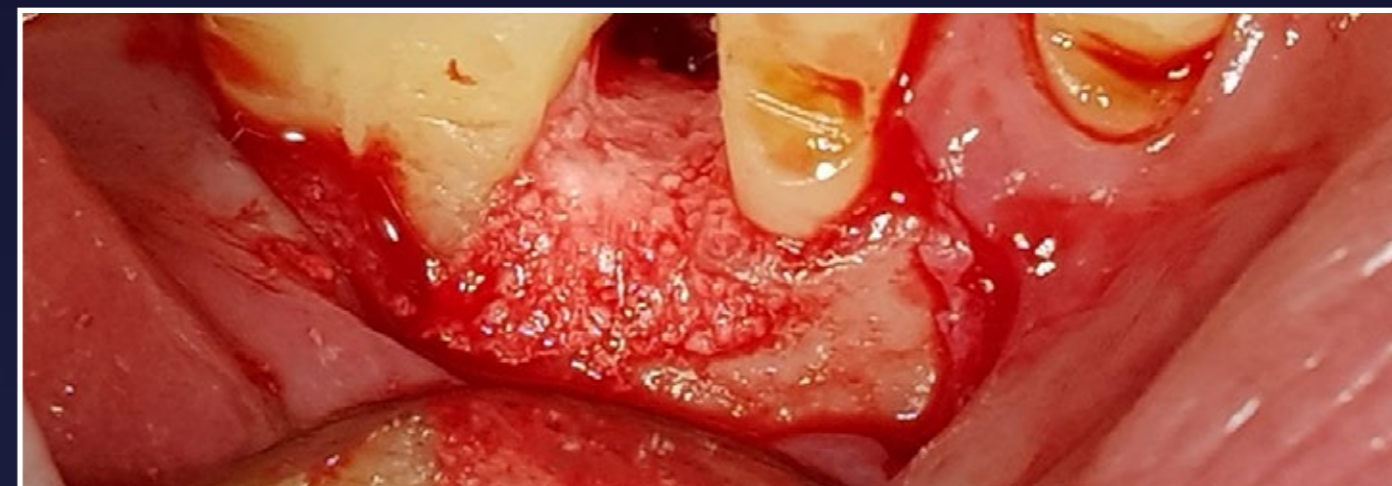
6. Grafted with EthOss, moulded to shape and dried

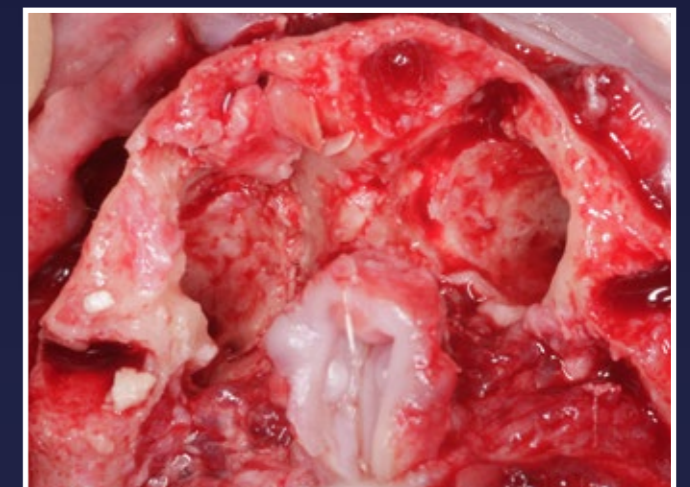
8. Defects left by removal of impacted canines

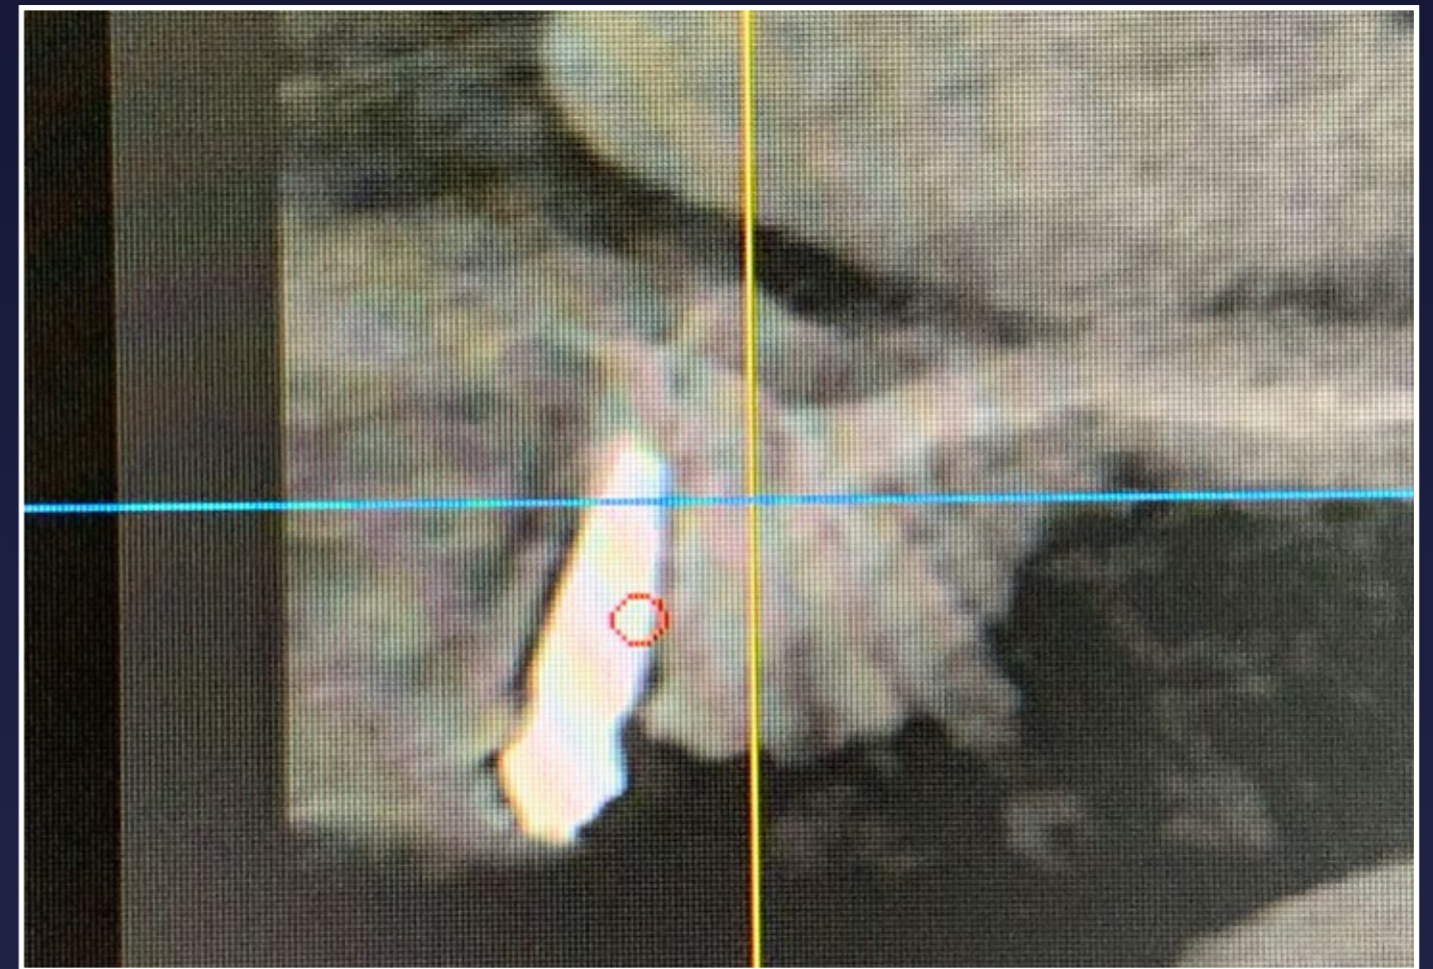
15. Post-op CBCT shows maturation of EthOss graft
