Volume 2

CASE

STUDY

8 Year Follow Up of a Buccal Defect, Long Term Hard and Soft Tissue Stability

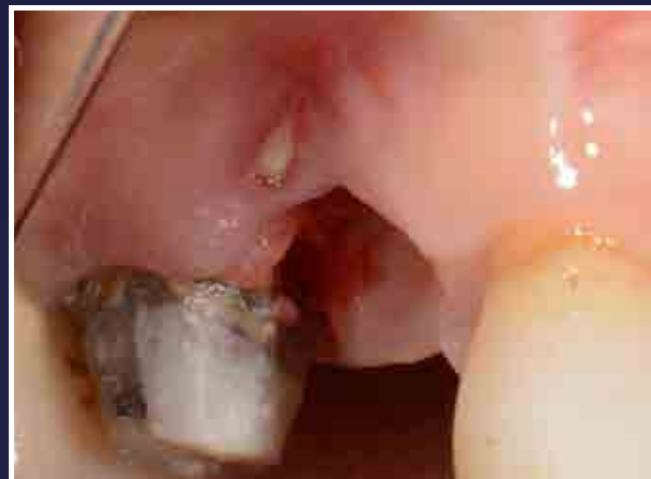
2. Soft tissue and buccal defect

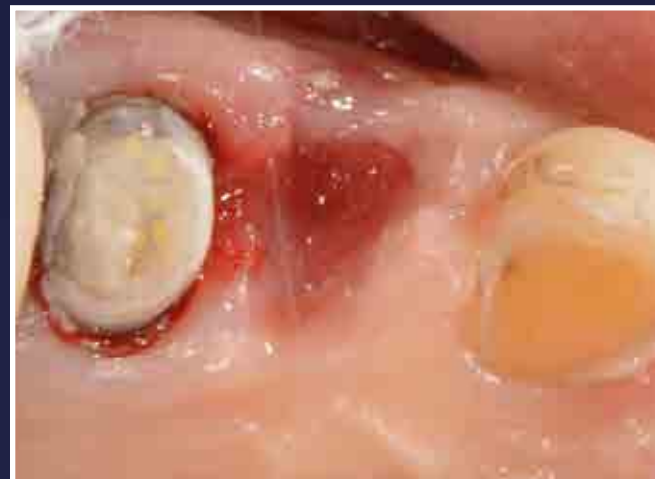
3. Soft tissue loss and buccal defect

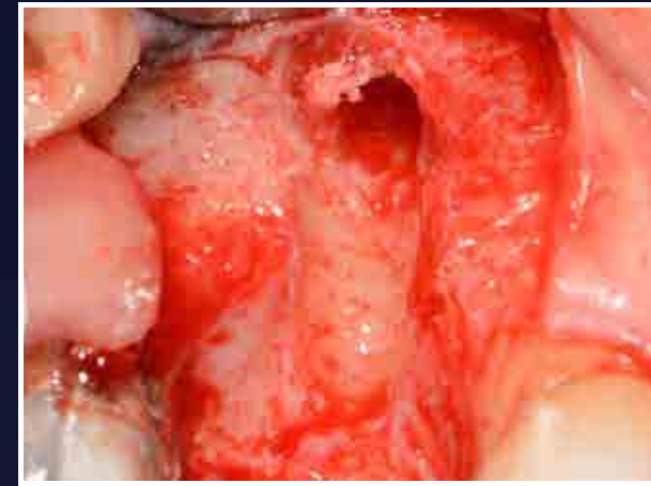
4. Soft tissue loss and buccal defect

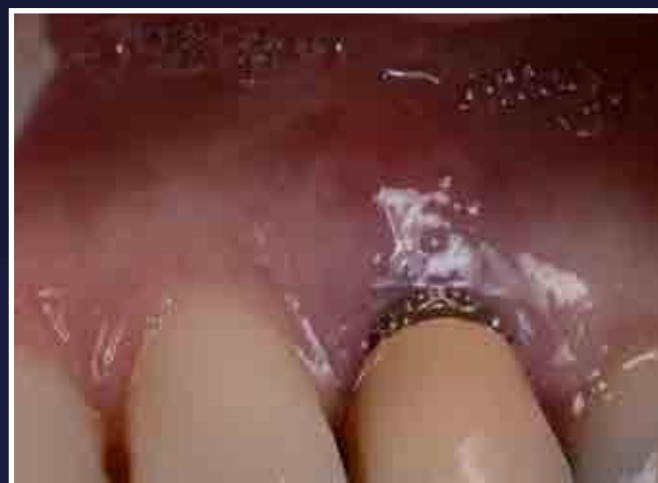
1. Initial situation - root fractured UL3

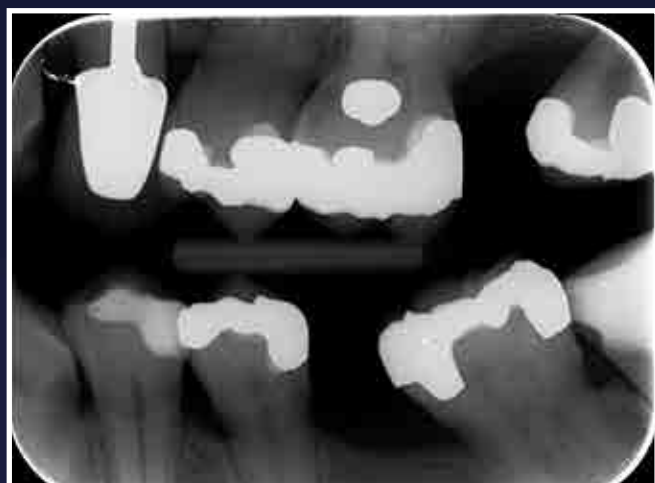
2. Radiograph initial status - post crown

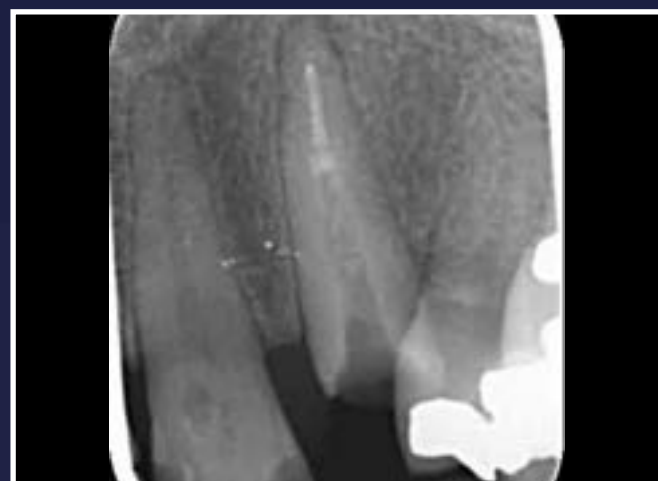
3. Radiograph initial status - root fracture

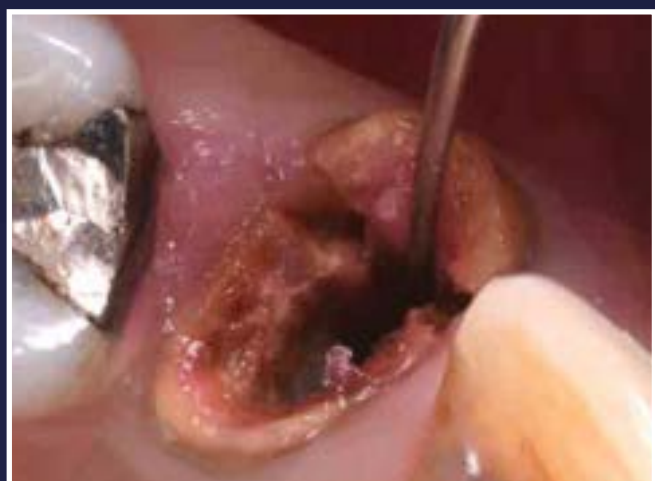
4. Clinical situation - root fractured

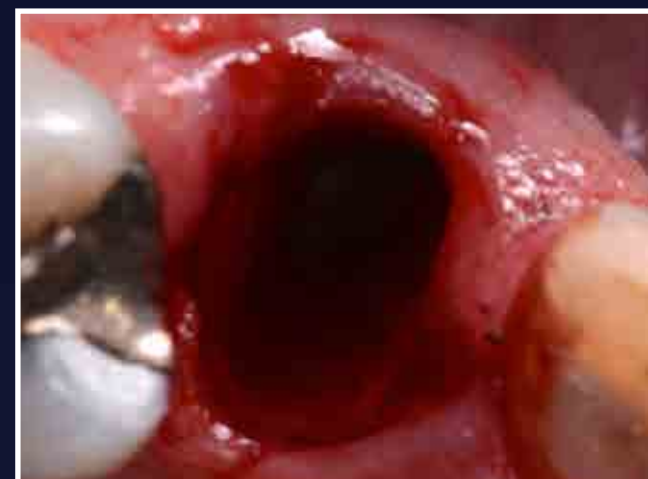
5. Socket post extraction. Decision to raise flap as buccal dehiscence

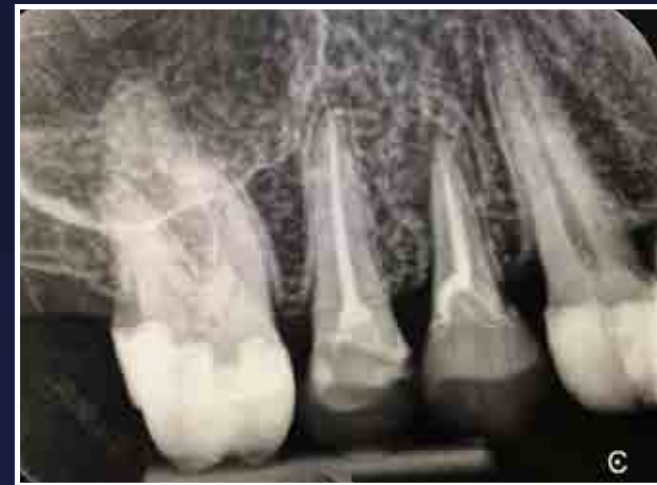
1. Radiograph initial presentation. Periapical lesion UL6

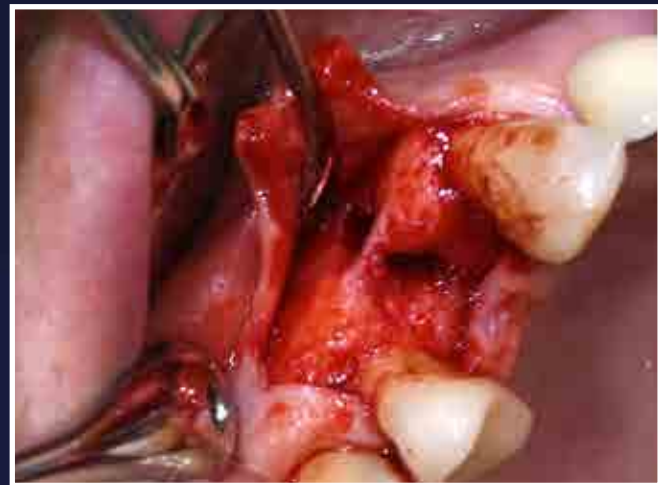
2. Bone defect with fenestration after extraction

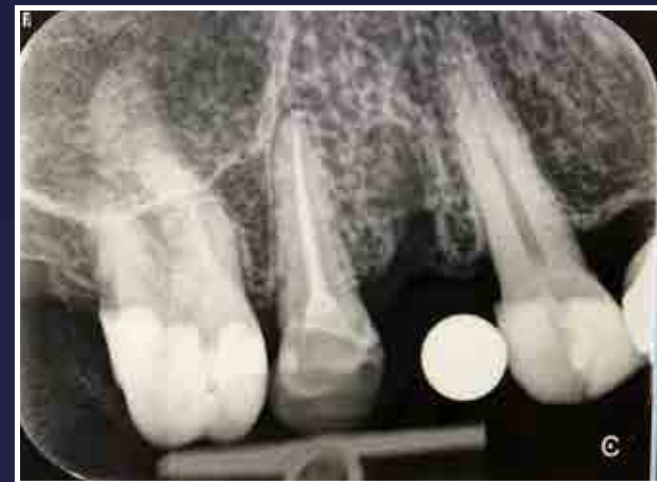
3. Radiograph after extraction with 5mm reference ball

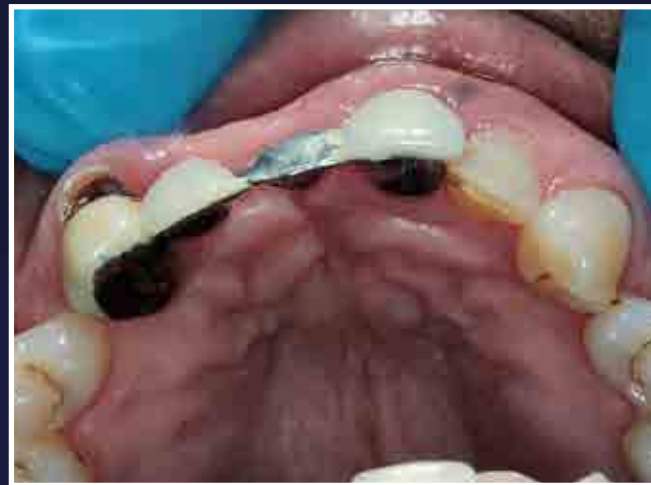
1. Occlusal view showing severe horizontal ridge defect. Mirror view

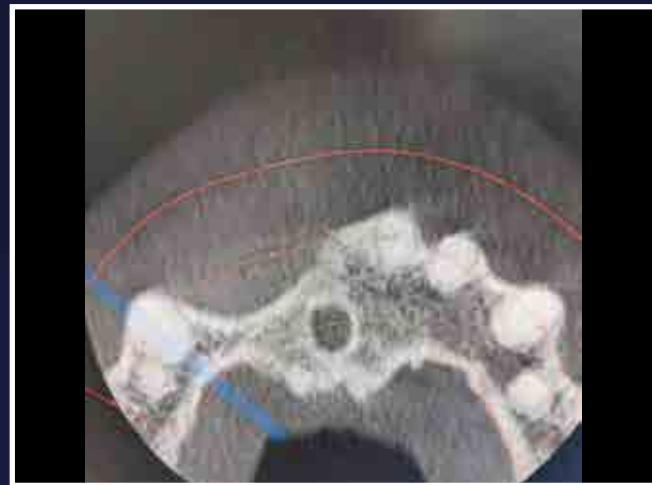
2. Occlusal CT scan view showing defect

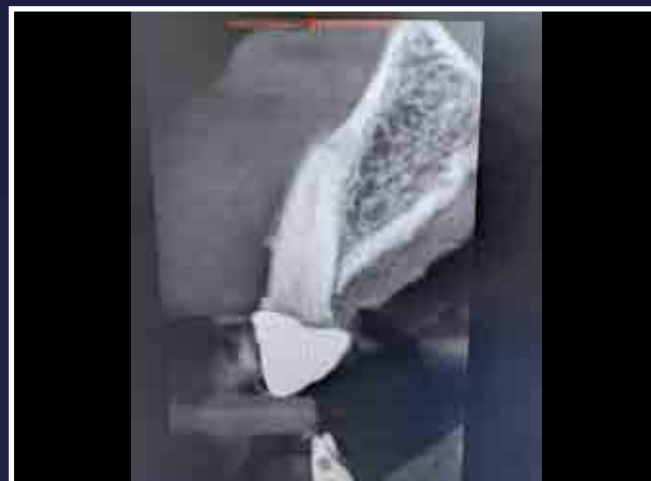
3. Upper right canine pre-operative CT view

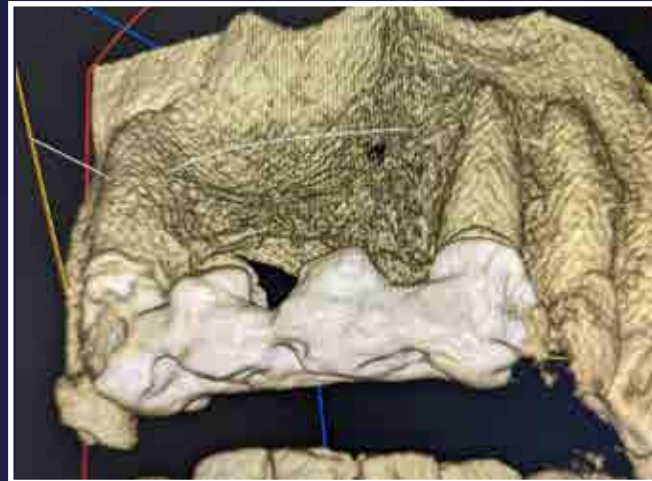
4. CT views of defect
