**ethOss**<sup>®</sup>

**Volume 3**

**CASE  
STUDY**

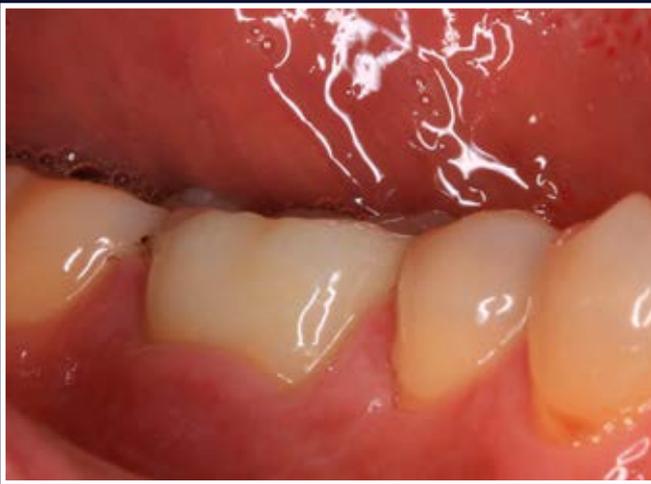
1. LR6 sudden deep mid buccal pocket and inflammation suggesting root fracture

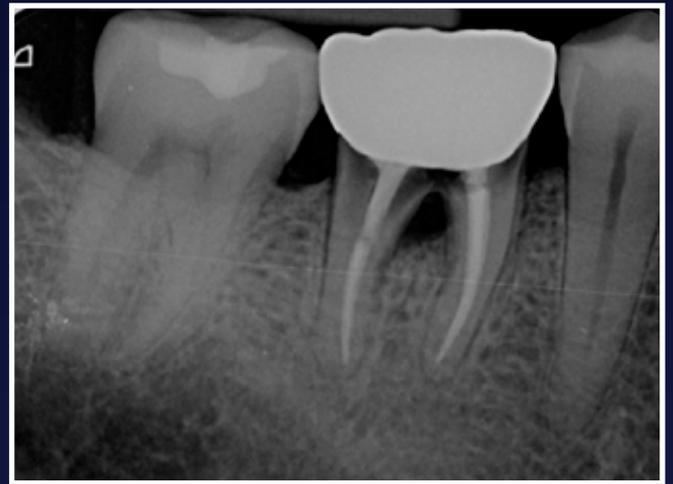
2. PA showing root fracture and furcal bone loss

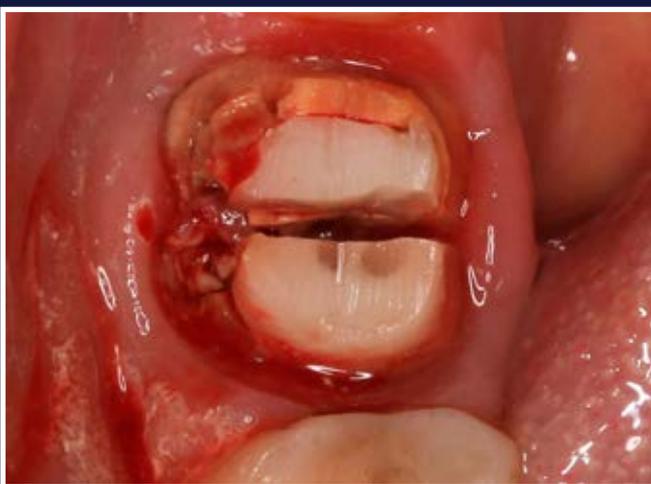
3. Extraction recommended and atraumatic extraction with crown removal and sectioning of roots

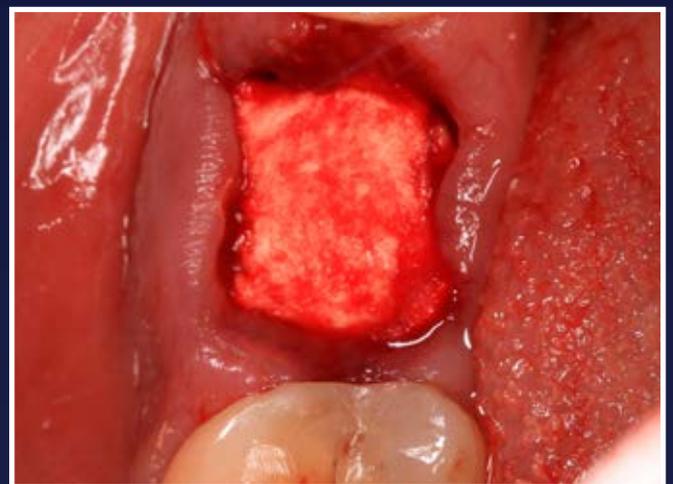
4. Haemostatic collagen sponge to prevent soft tissue ingress and optimise healing

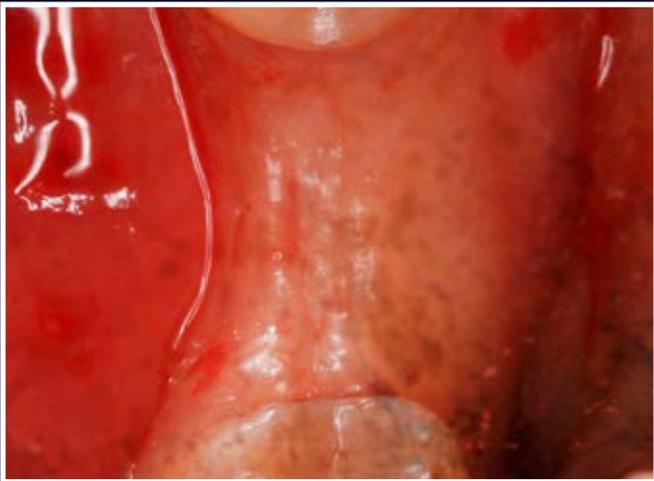
5. Healed ridge 3 months post extraction - buccal bone defect

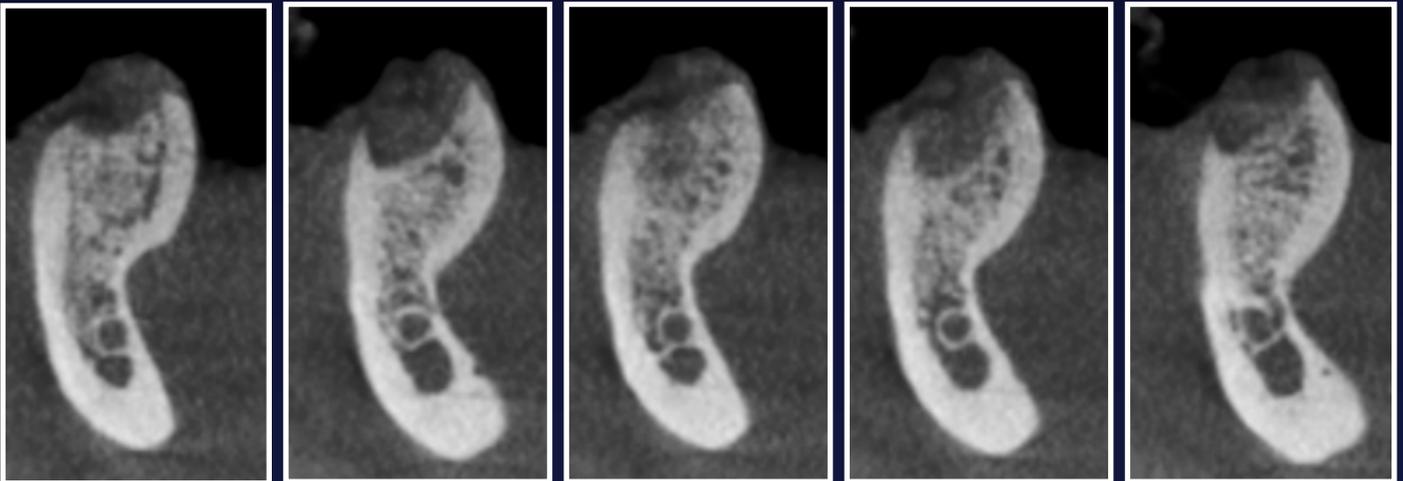
6. CBCT taken for implant planning showing bone loss buccally

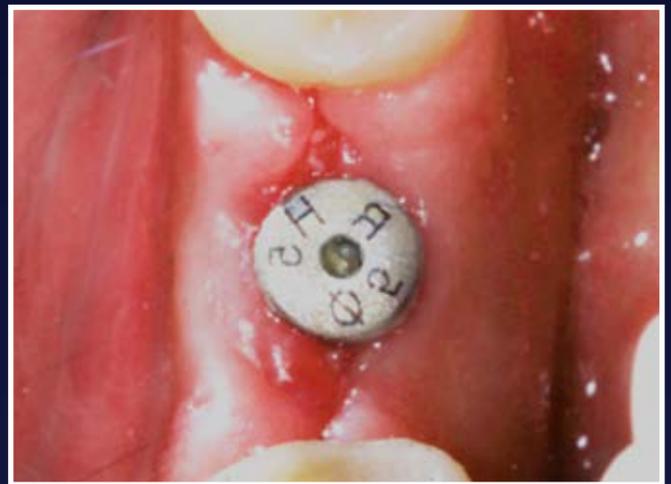
10. Healing 2 weeks post placement

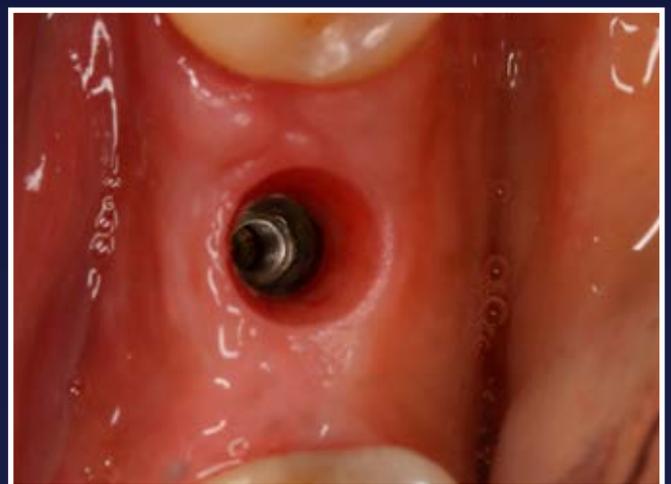
12. Soft tissue healing and buccal bone volume restored

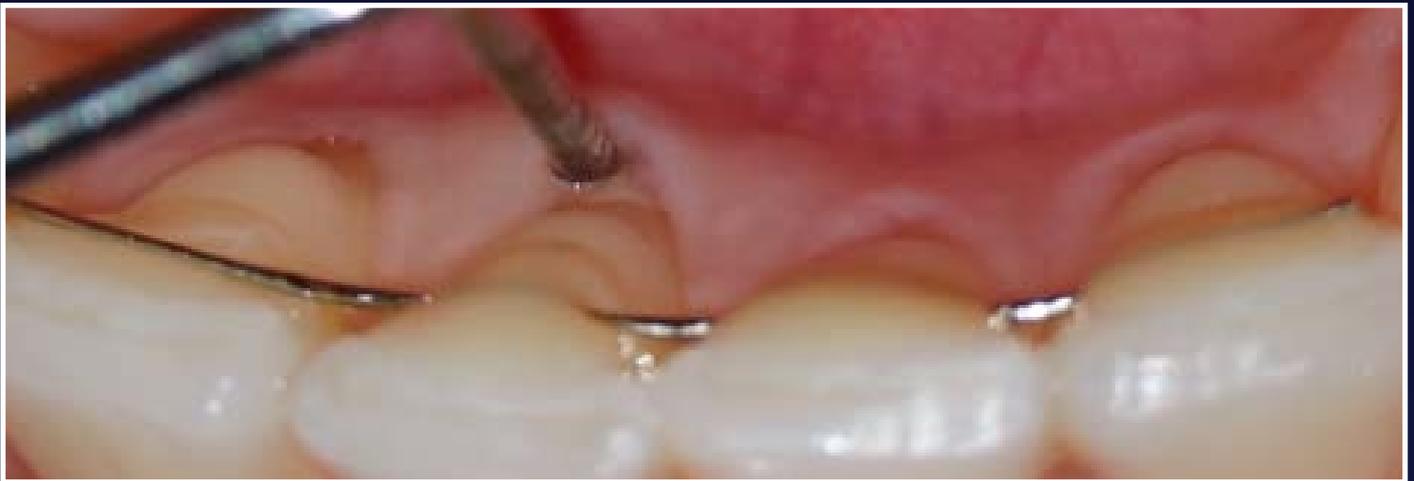
1. Suppuration on probing

2. Bleeding on probing - 8mm periodontal pocket

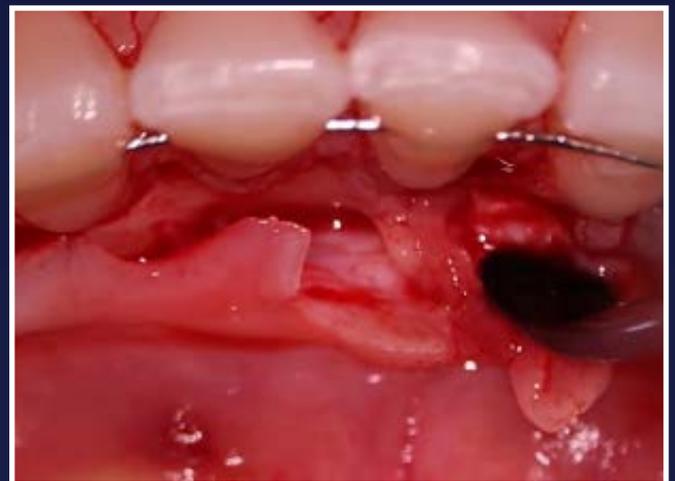
3. Granulation tissue associated with cemental tear

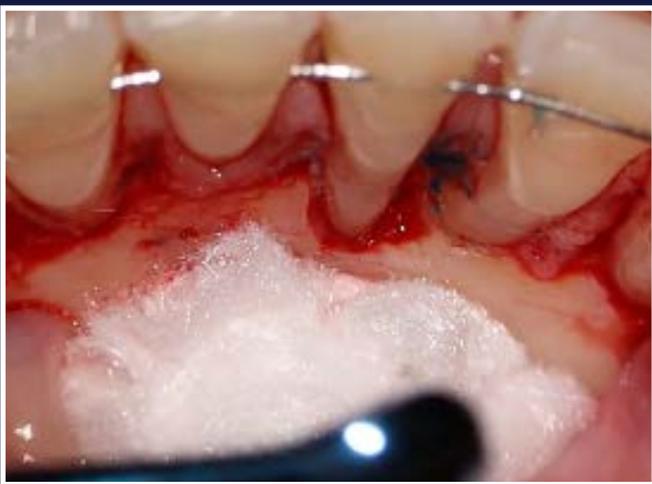
8. Oclusal view of the defect

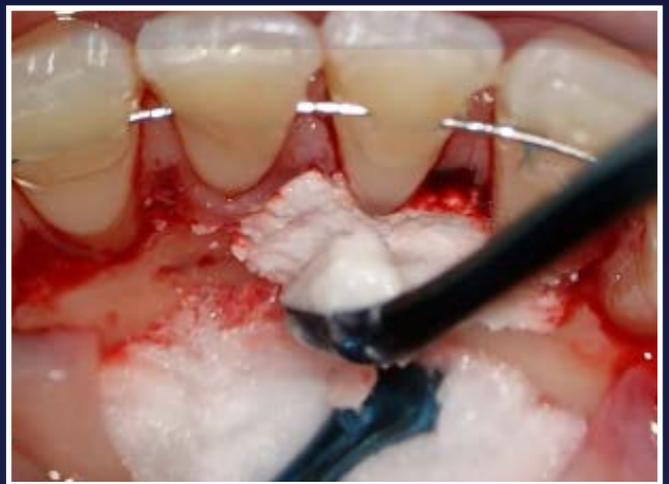
9. Filling the defect with EthOss® bone grafting material

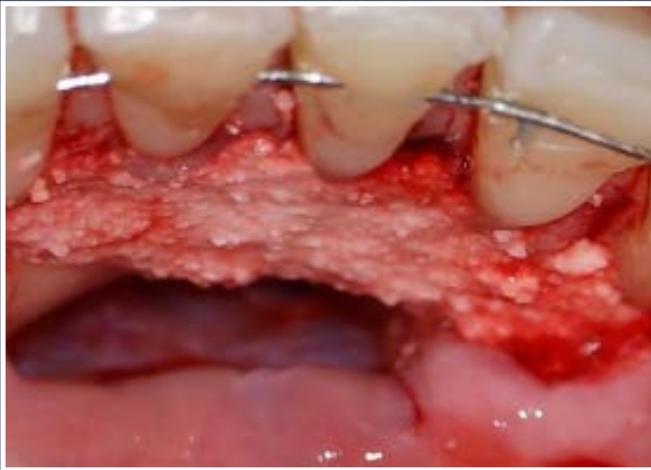
10. Complete filling of the defect and thickening of the lingual bony wall

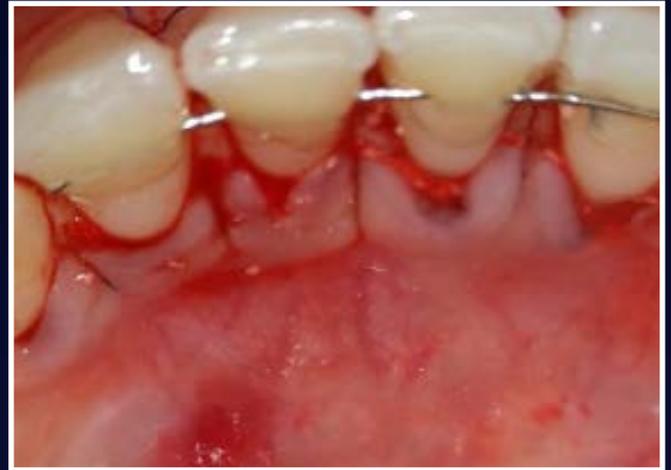
11. Sutured

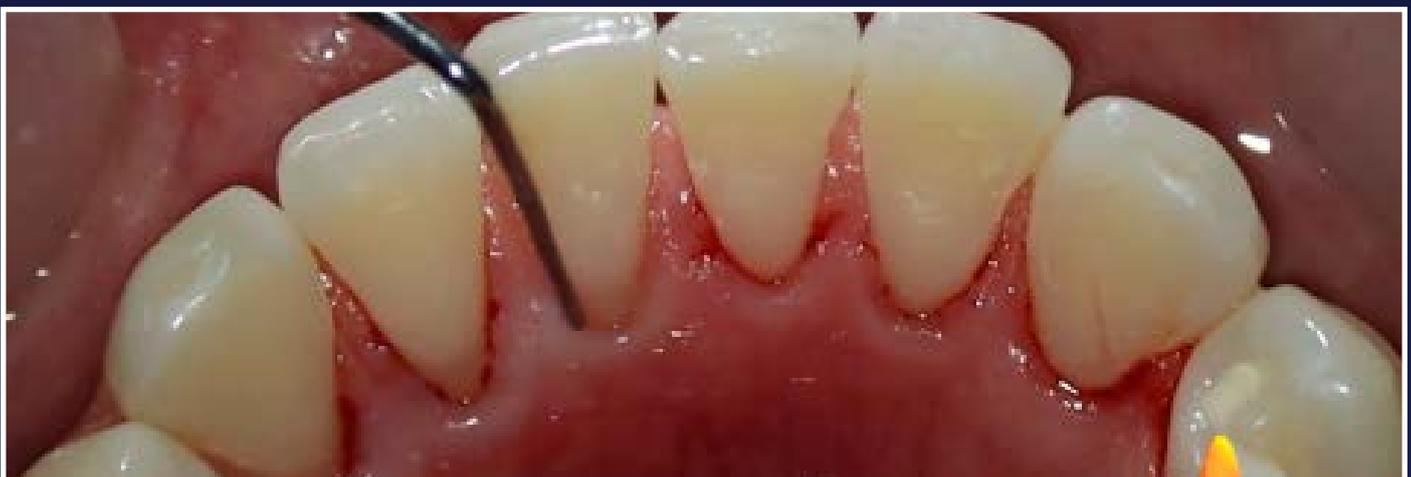
14. Final situation 3 years later

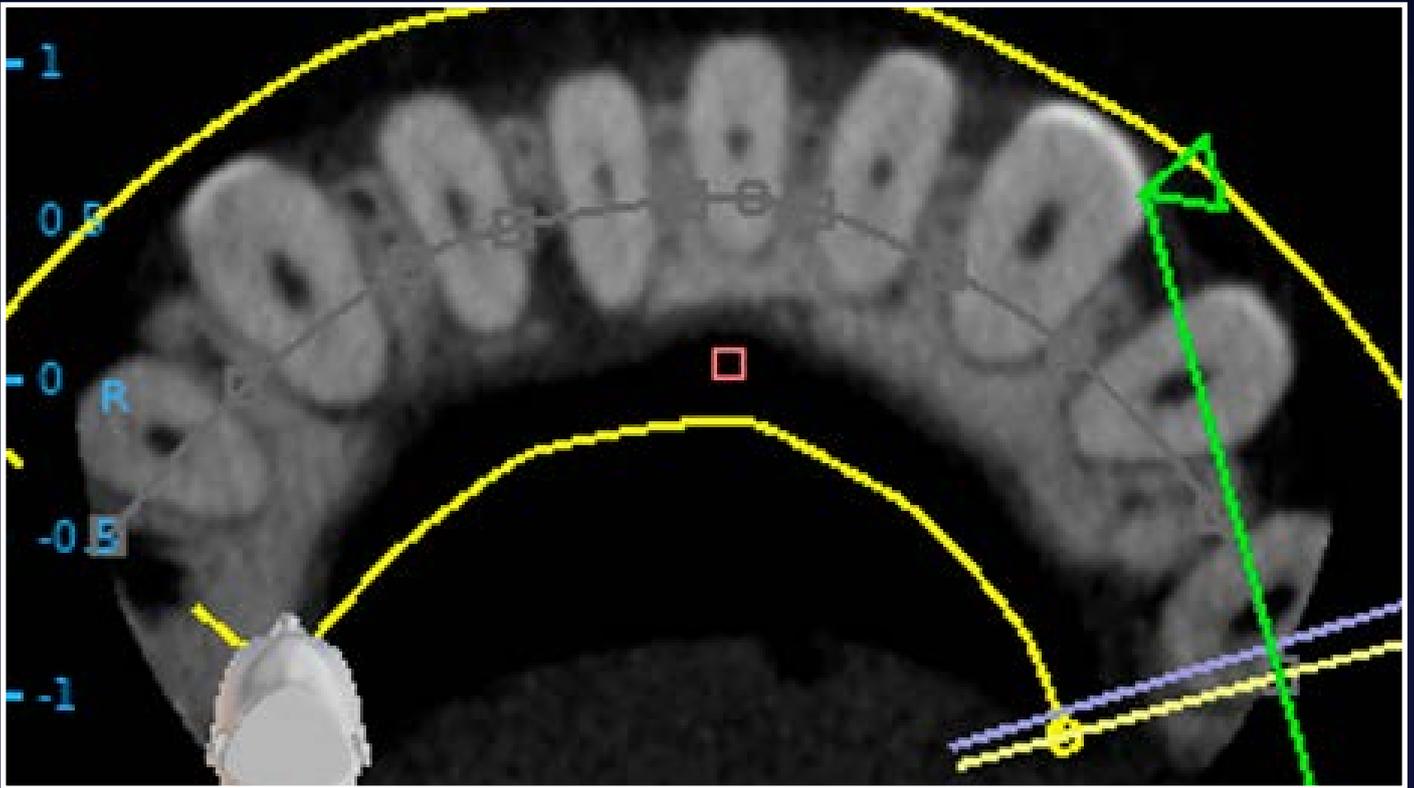
15. Initial CT scan

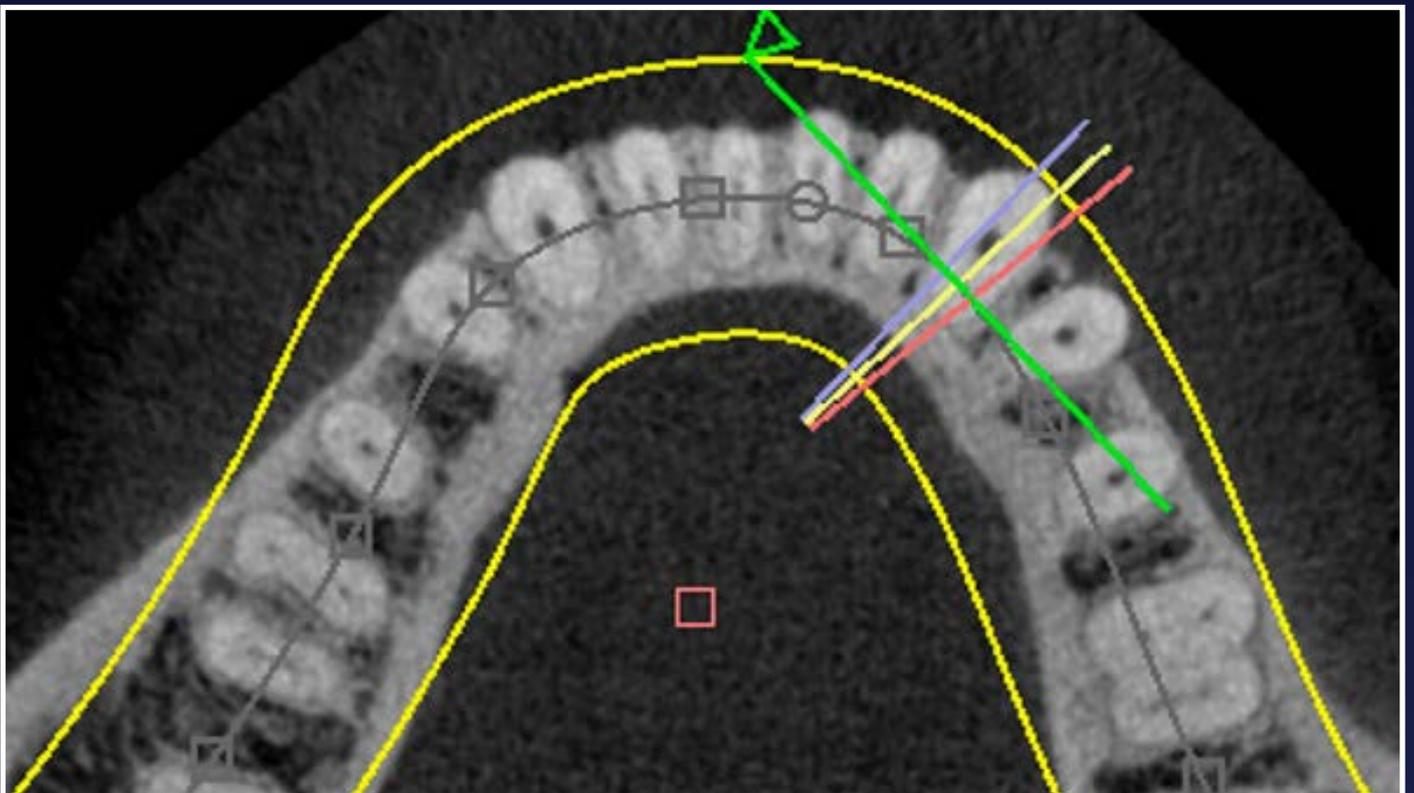
16. Final CT scan 3 years later

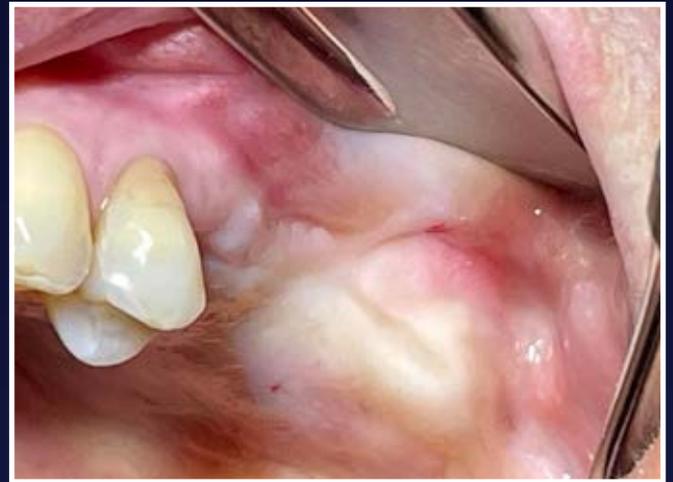
2. Tooth extracted - 12 weeks later

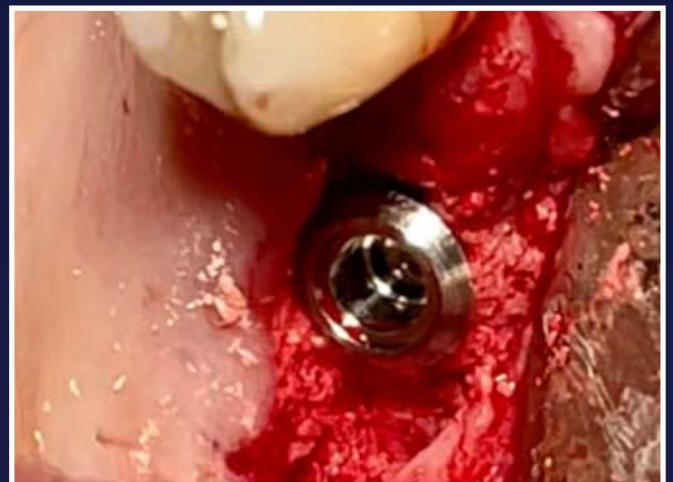
4. Site degranulated and Southern ITT 6 x 8 mm placed

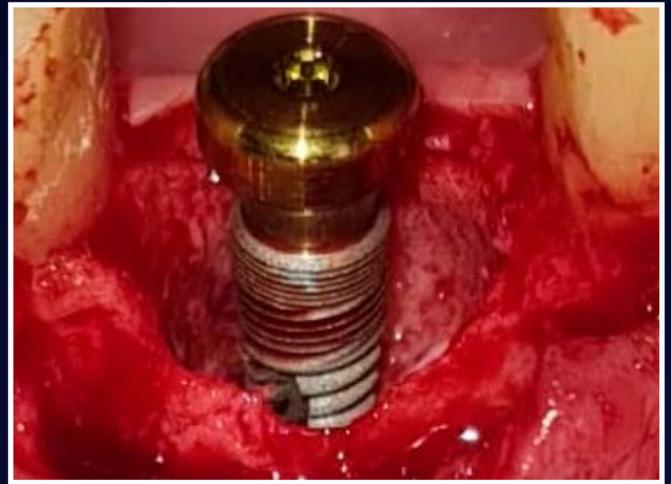
6. Implant placement. 35NCM insertion torque

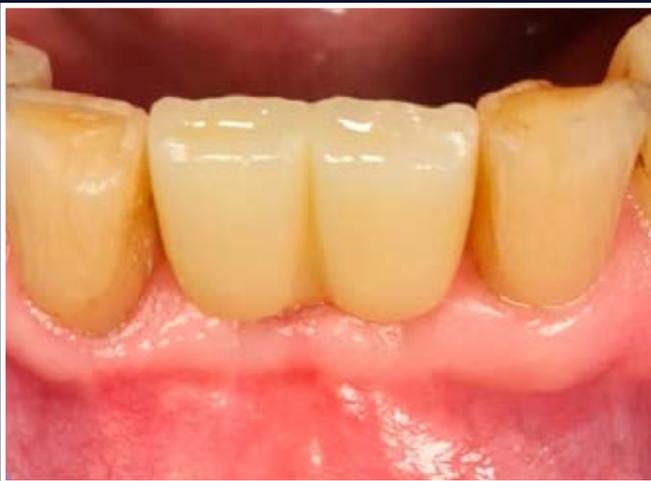
13. Seating of prosthetics. Screw retained with good access for hygiene

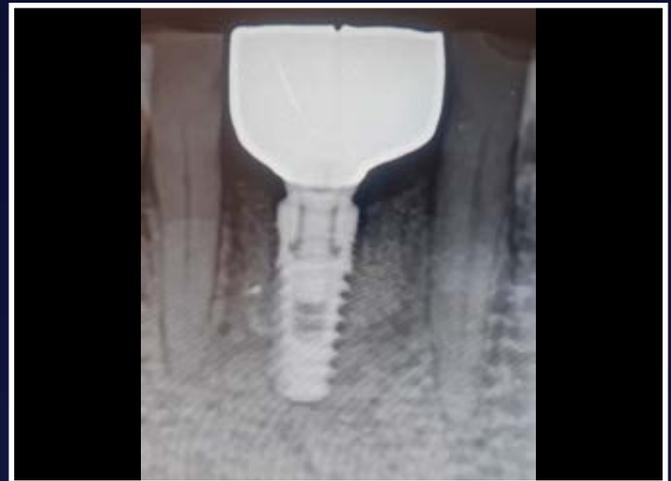
14. Final PA showing graft maturation and seating of prosthetics

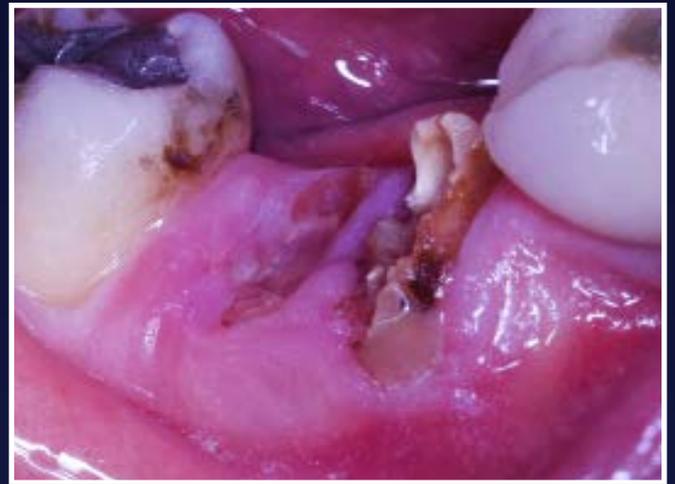
2. Initial condition

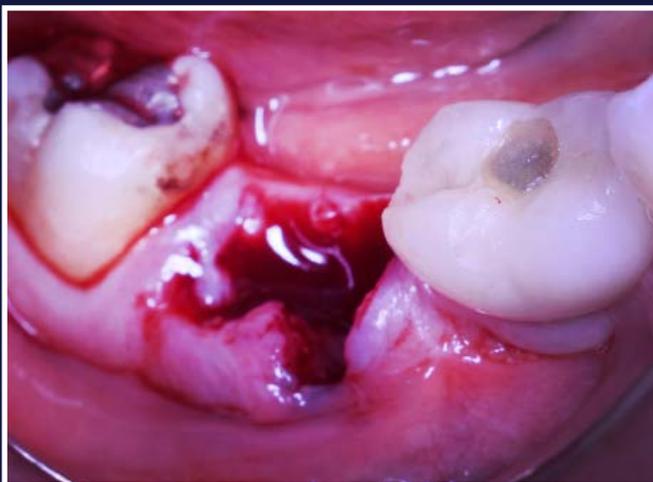
3. Extraction

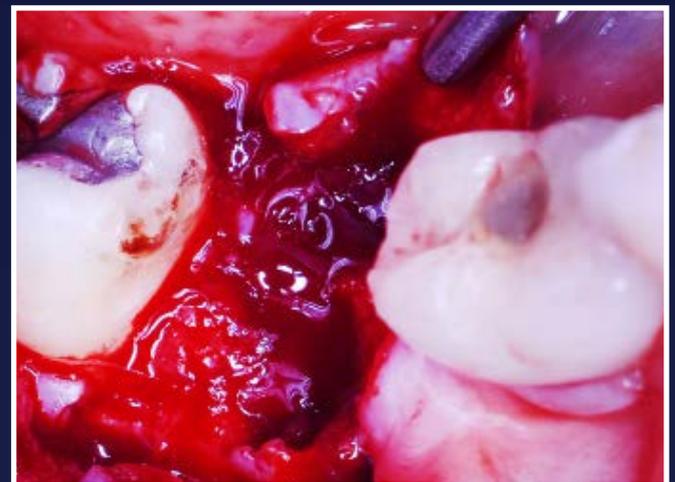
4. Flap raised

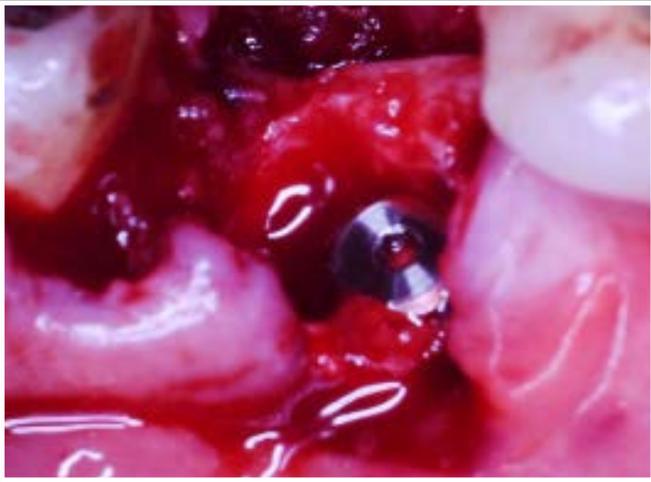
5. Implant placed after degranulation

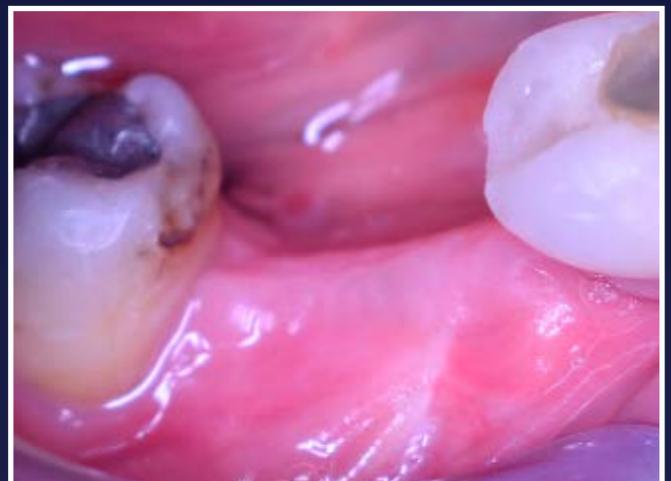
10. Second surgical phase

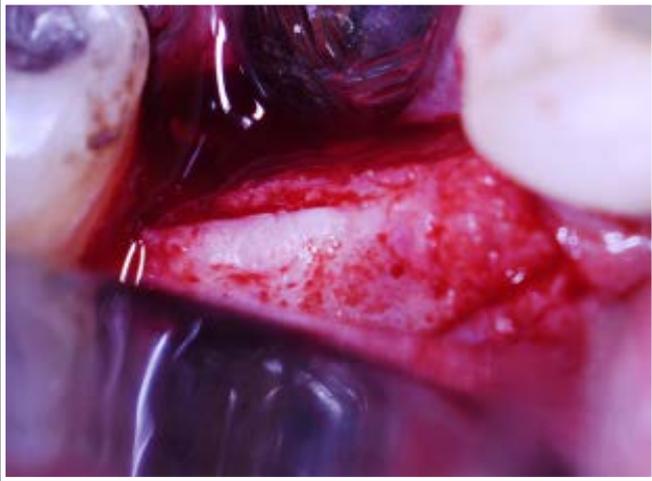
11. Bone regeneration with EthOss®

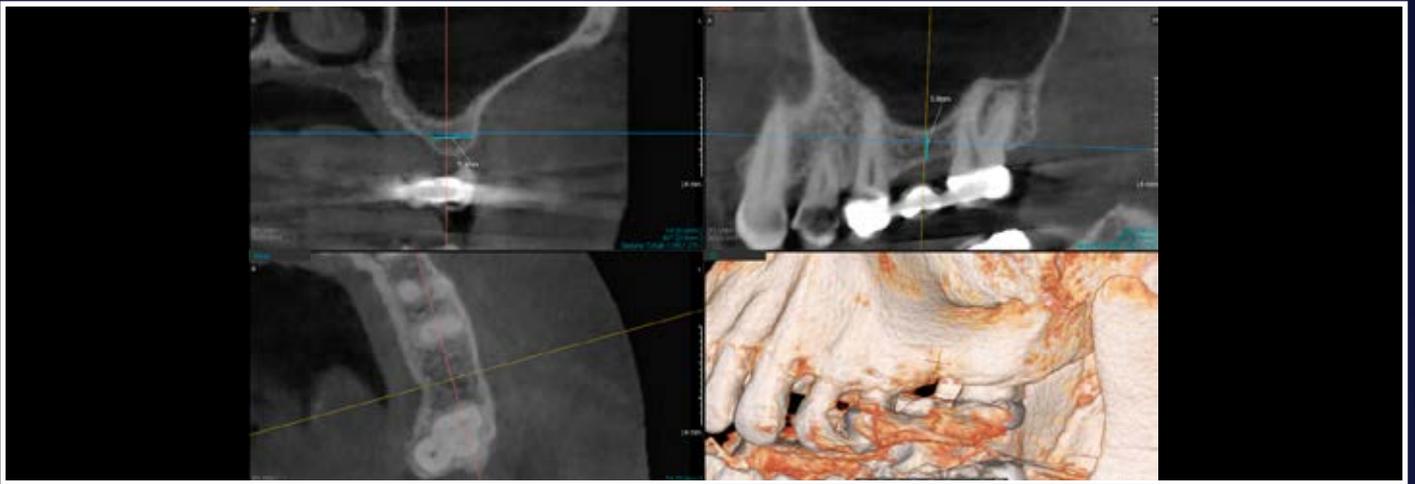
1. CBCT is done to plan the surgery

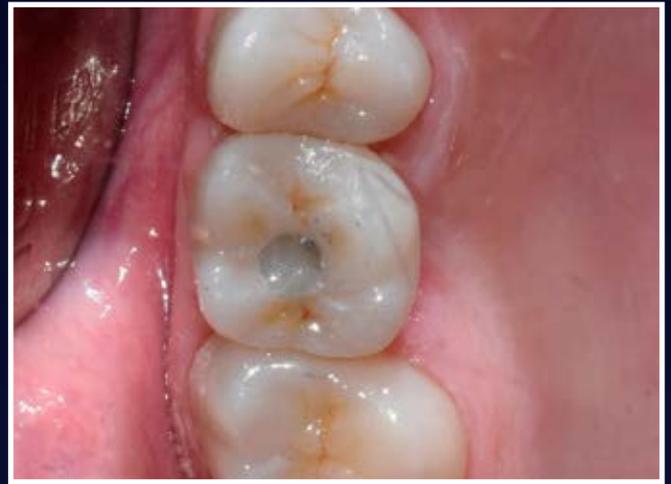
17. 3 separate crowns, stained zirconia.  
Noticeable tissue compression

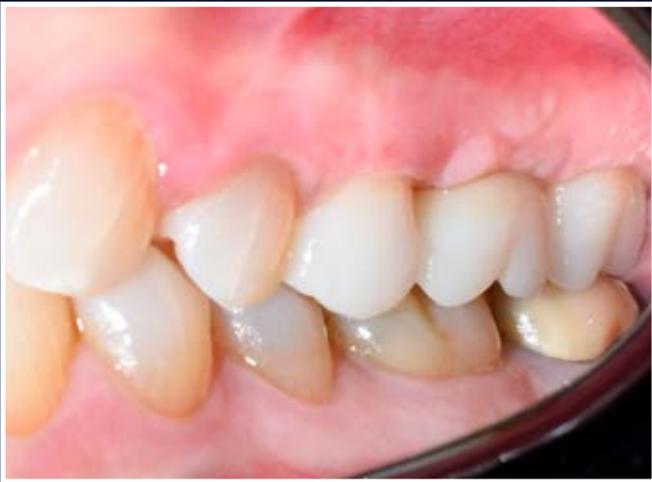
18. Side view, notice the keratinized mucosa  
around the implant

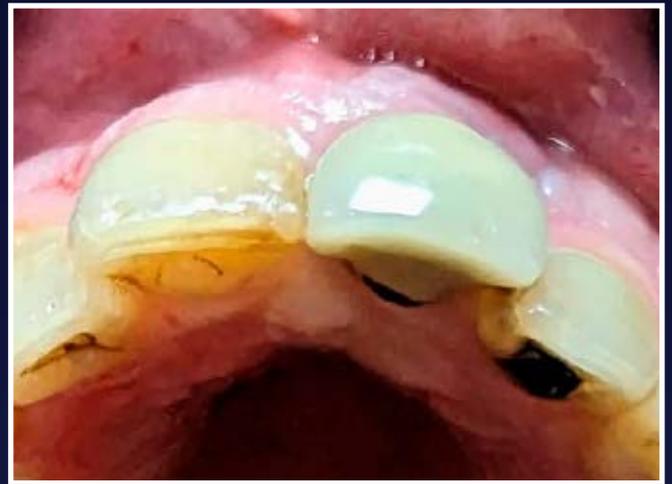
2. Showing ridge form

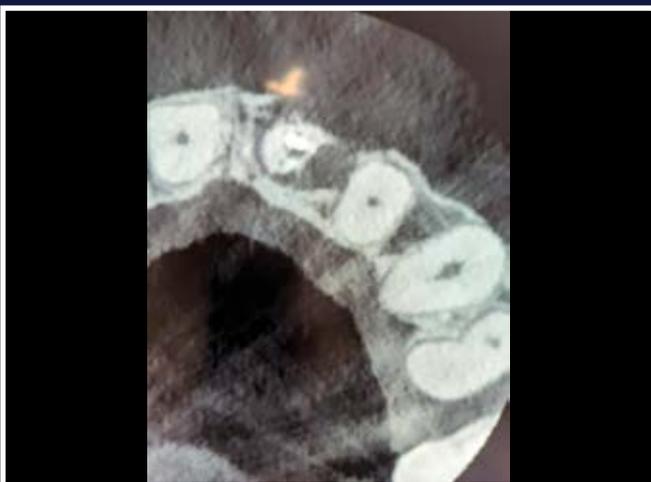
3. CT slice showing extent of defect

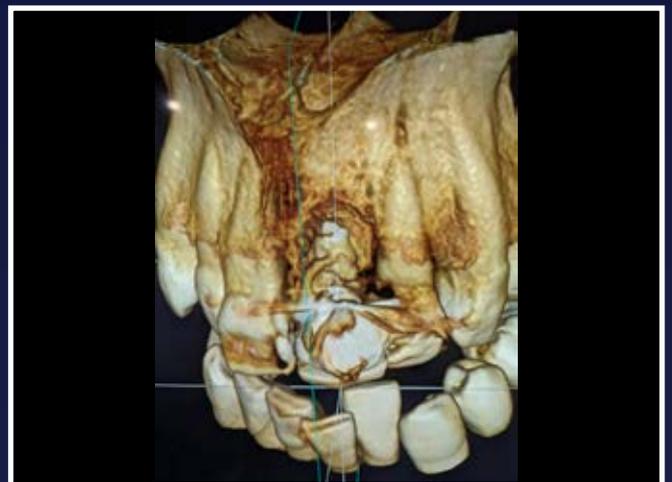
4. CT render showing tooth not in bone

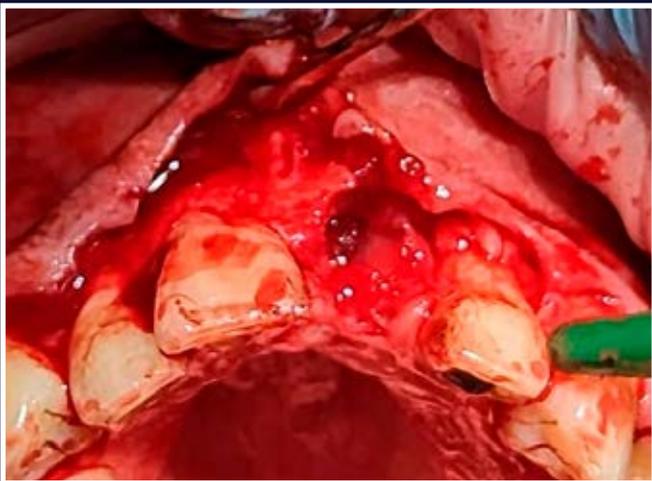
7. Flap raised to view defect

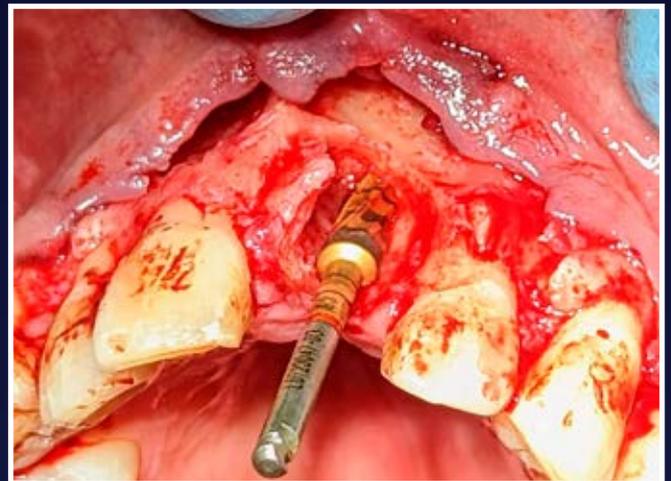
8. Post defect degranulation - Versah Drill used to create osteotomy

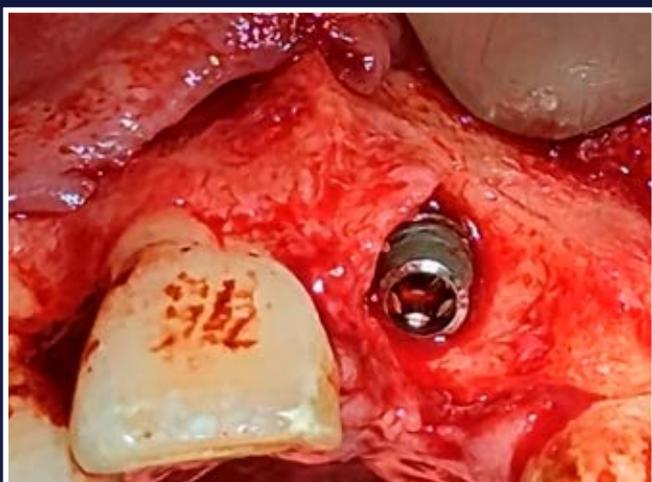
9. Straumann BLX implant placed

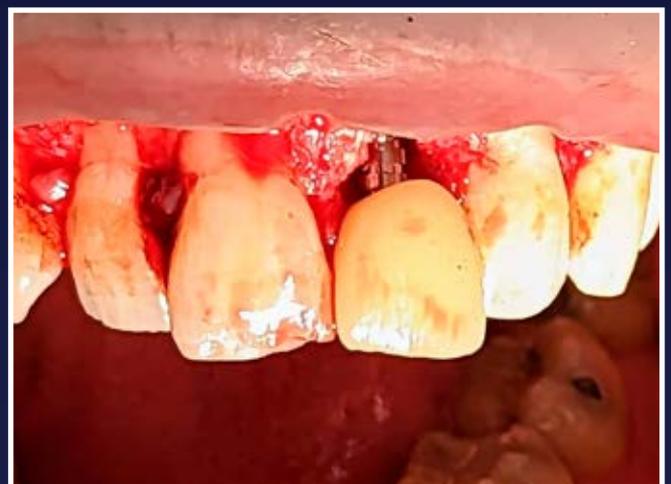
16. Try in of shell crown

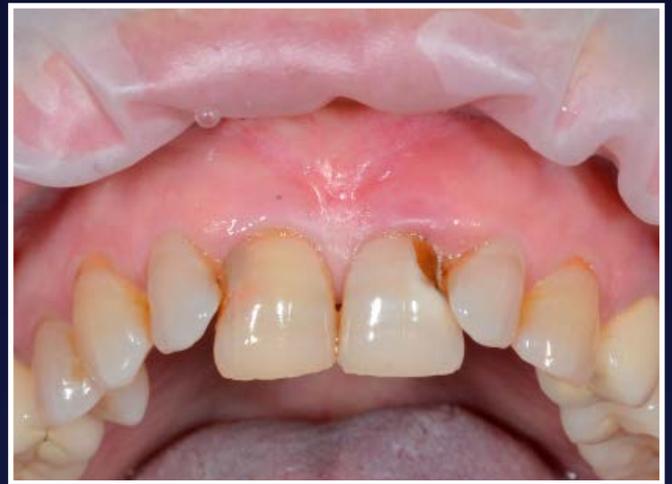
2. Front view

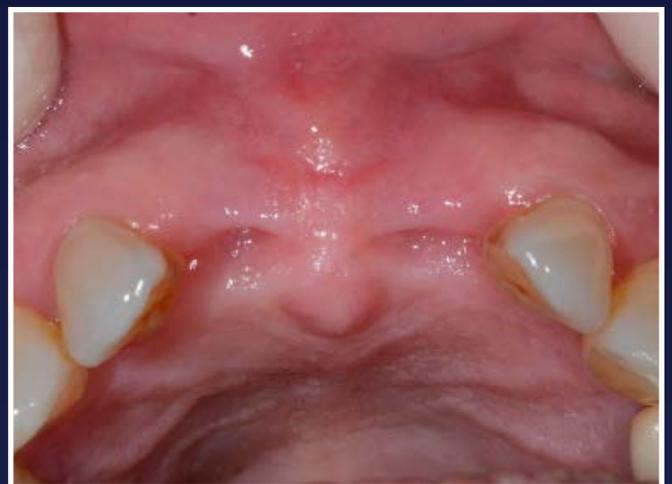
4. Occlusal photo one month post extraction

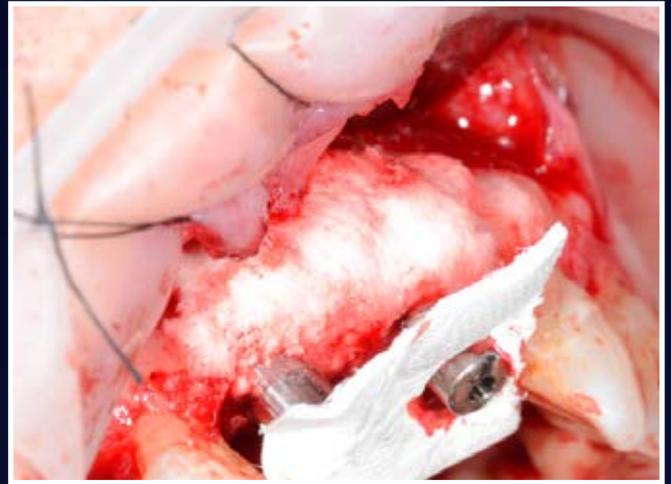
12. Bone regeneration - EthOss® bone grafting material placed

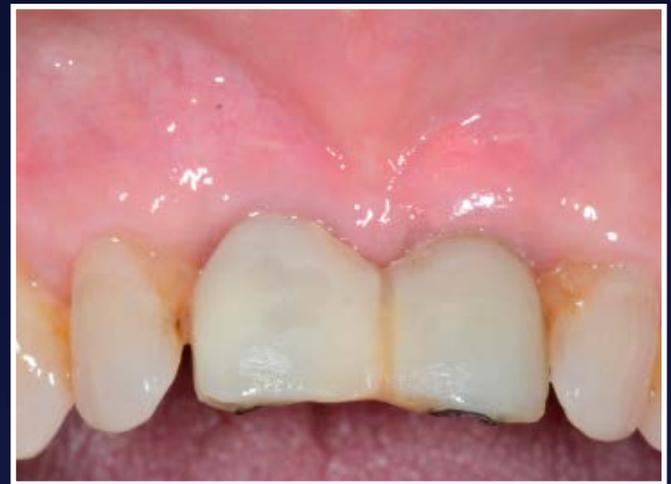
14. Three months post bone regeneration

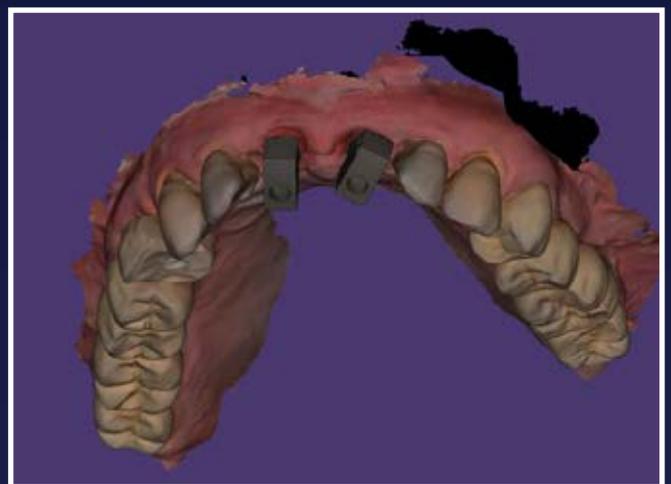
16. Digital impression

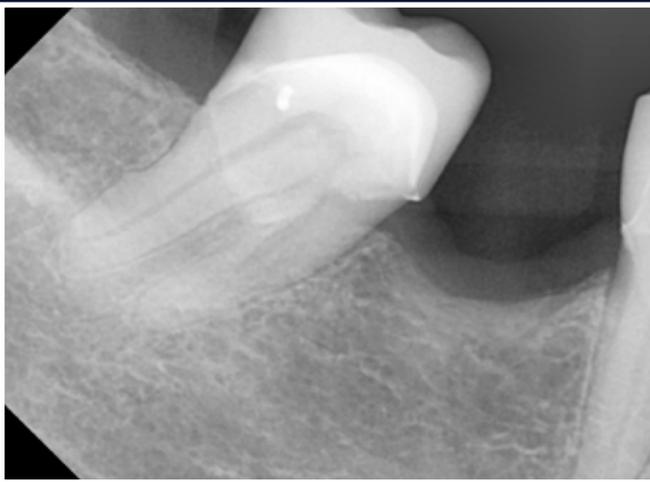
1. Pre-op situation. Crown requires replacement and tooth requires treatment

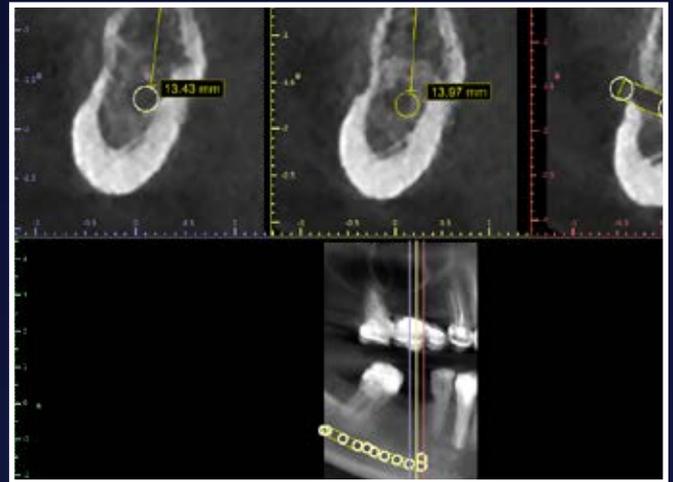
2. Pre-op bone evaluation using CBCT

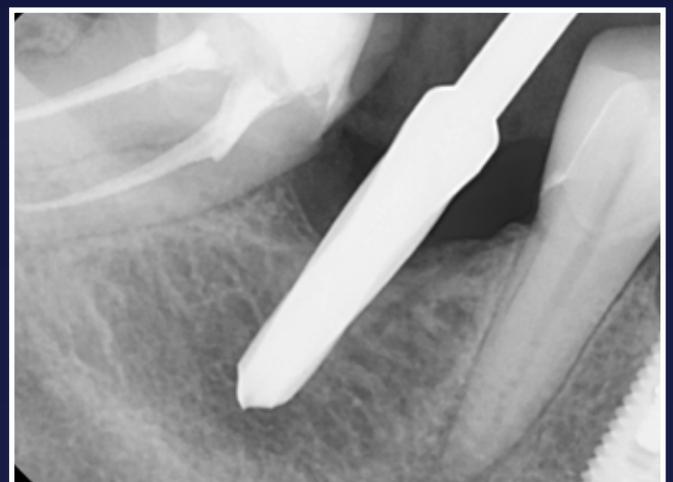
4. PA radiograph showing osteotomy preparation

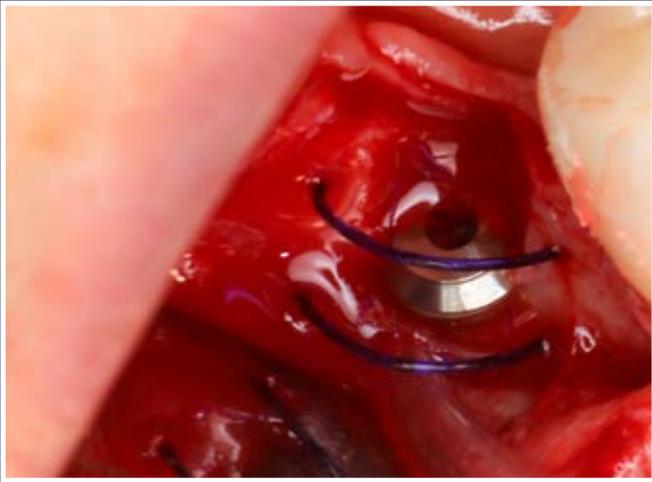
5. TRI Vent 4.7x8mm placed. Deficient buccal bone. PDS 2.0 sutures for tenting effect

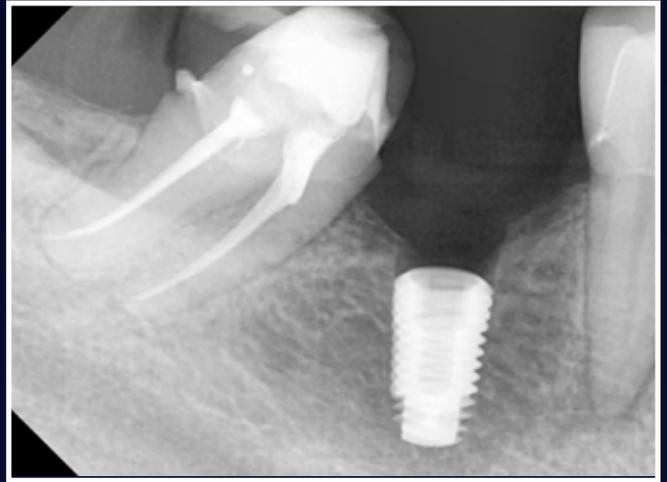
6. PA radiograph showing implant in place

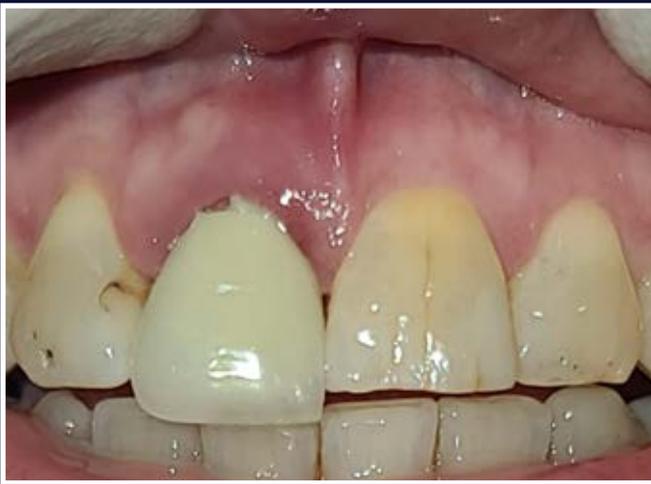
1. Failed UR1 post crown

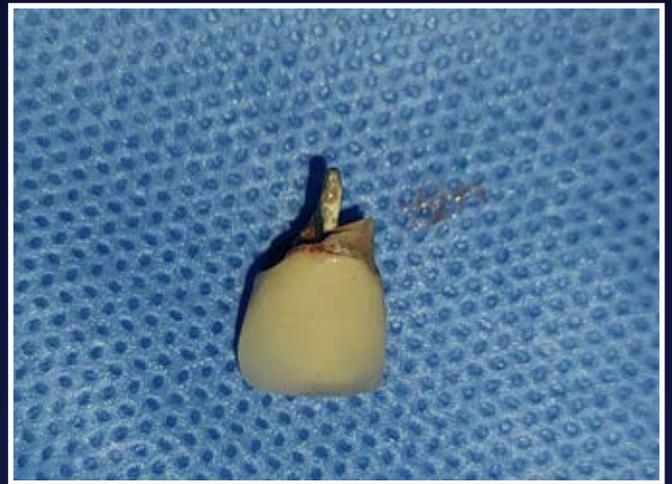
2. Crown removed. Subgingival fracture

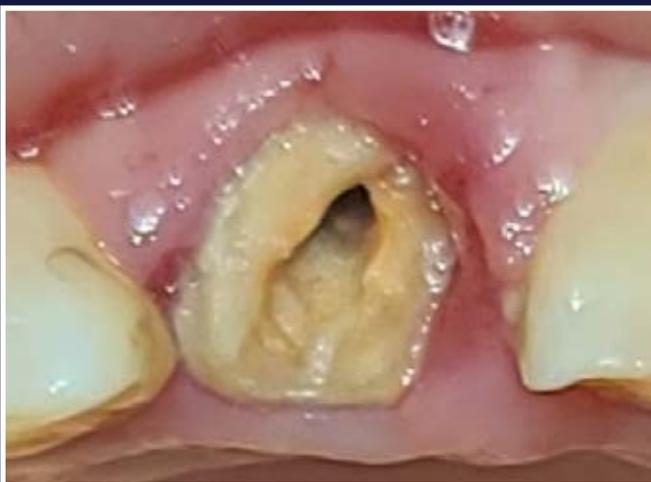
3. Occlusal view of the retained root

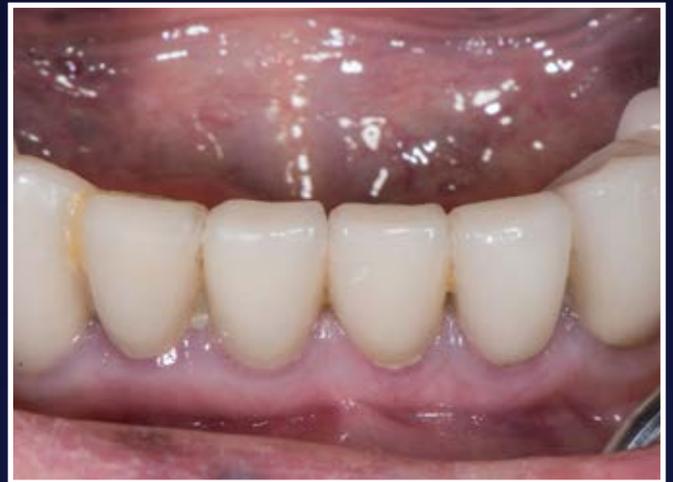
2. Pre-op

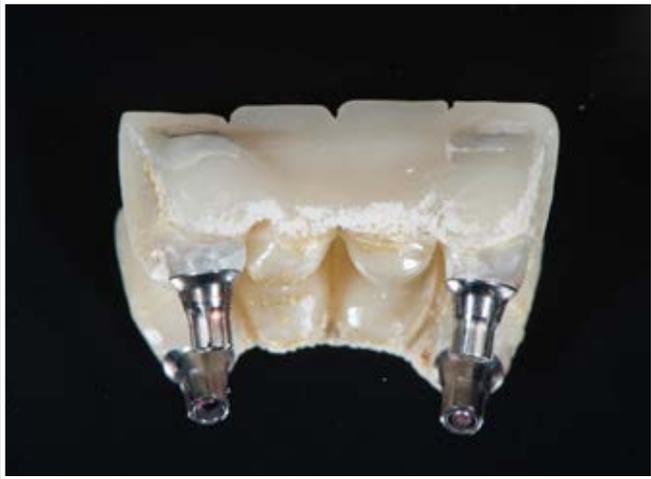
16. Inadequate hygiene

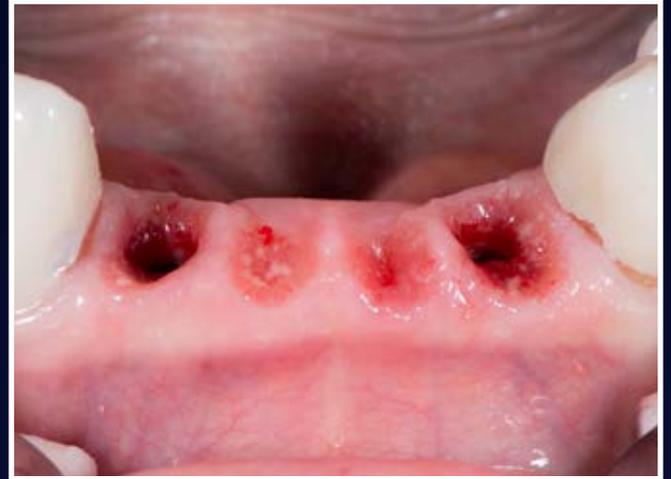
17. Soft tissue with good volume - 4 months post surgery

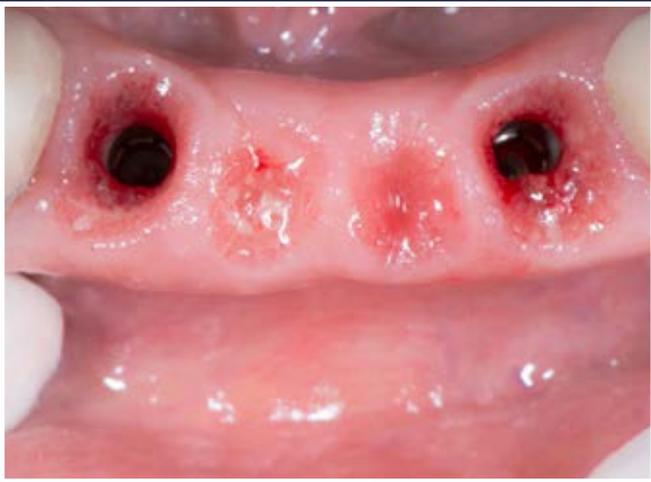
18. Soft tissue occlusal view, because of inadequate hygiene some superficial inflammation

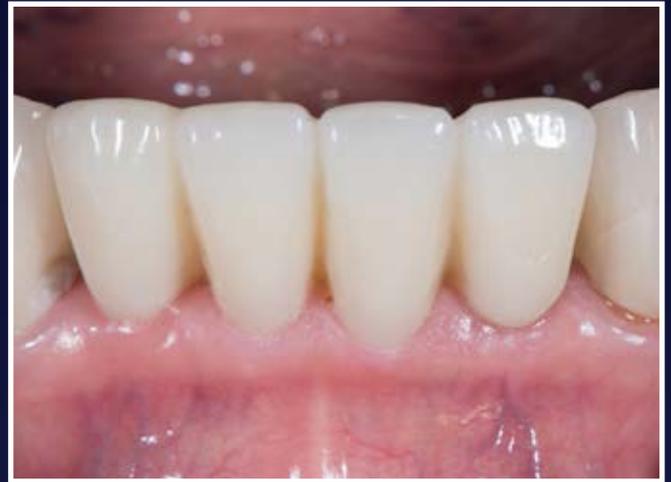
19. Final bridge seated

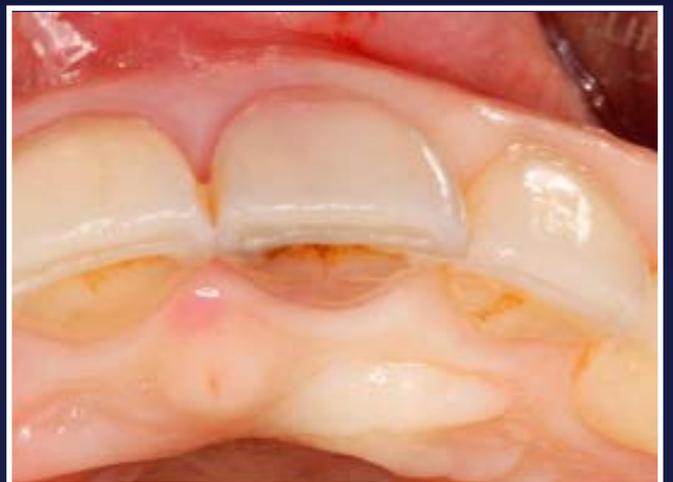
4. Pre-op occlusal view

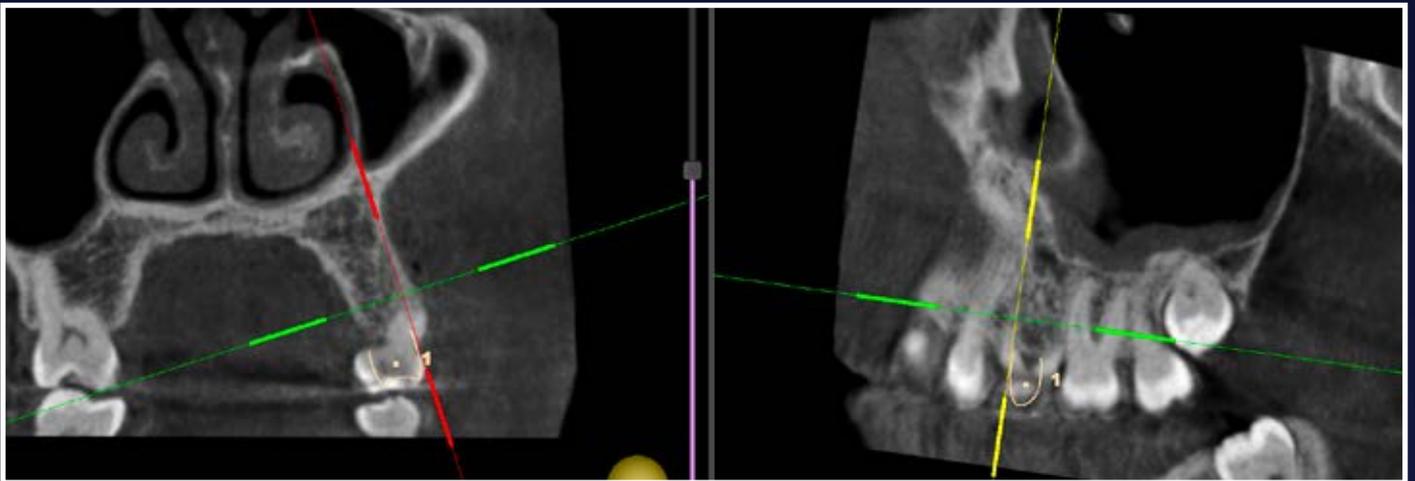
1. Pre-op CBCT

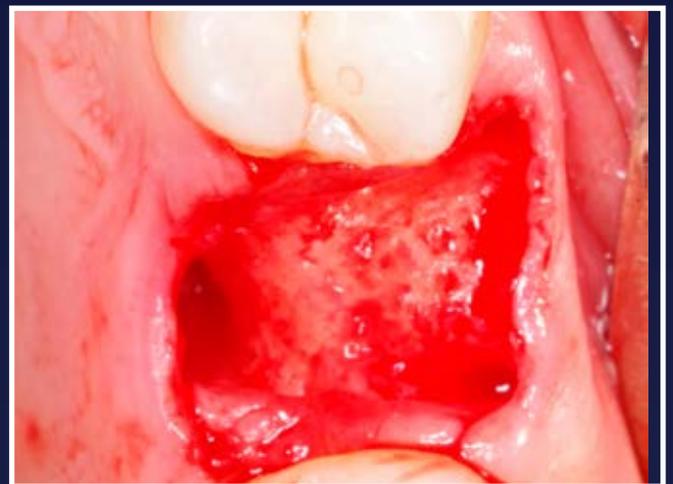
3. Site post atraumatic extraction

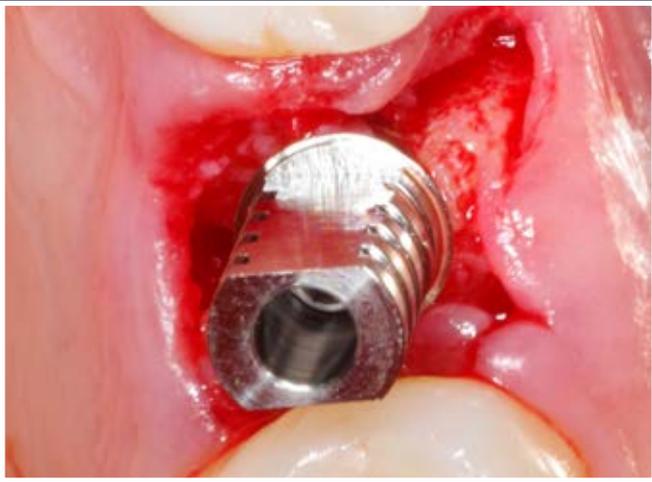
6. Implant placed in prosthetically favourable position
