**ethOss**<sup>®</sup>

**Volume 3**

**CASE  
STUDY**

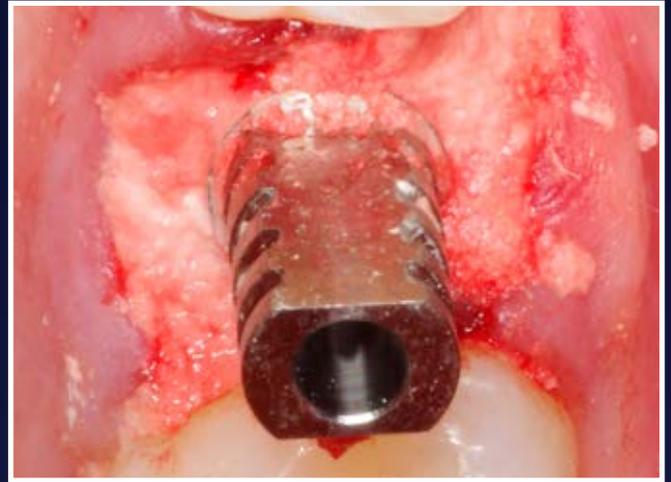
7. EthOss® bone graft set after 4 minutes of moderate compression

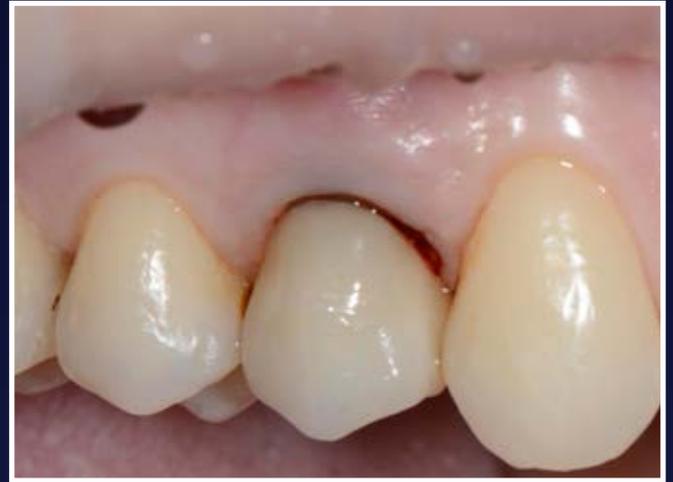
2. Initial situation before extraction

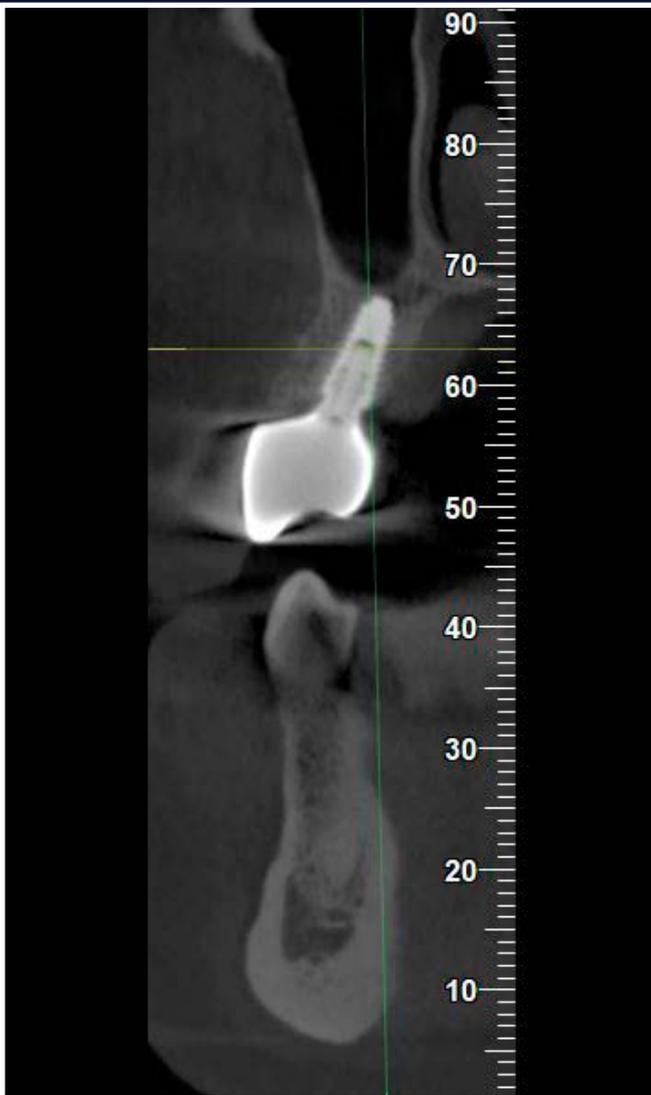
19. 1 year follow-up CPCT cross section - excellent new bone buccally and lingually
